Report following railway power disruption on 9th August 2019

3rd January 2020

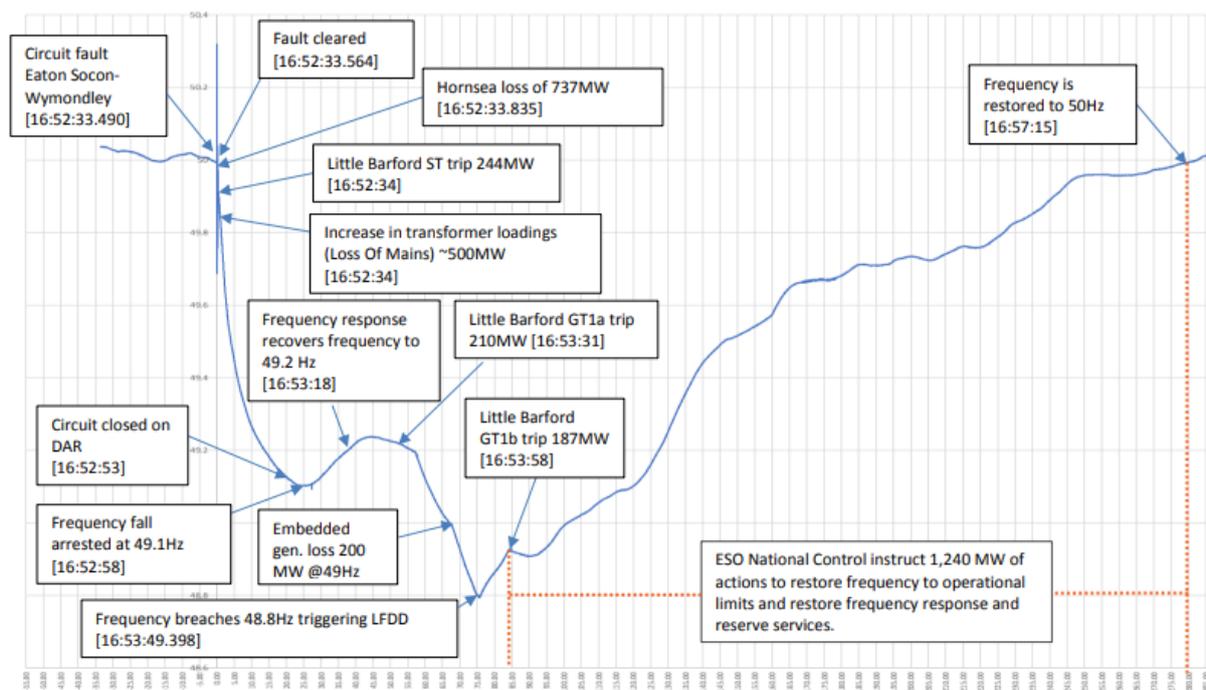
During the power disruption, changes to the grid supply were transferred to Network Rail Infrastructure. The supplied power frequency dropped from a nominal 50.0Hz to a low level of 48.8Hz after 16 seconds. The frequency remained below 49.0Hz for approximately 33 seconds and was restored back to its nominal value of 50Hz 3 minutes and 36 seconds later.

Figure 1 – Annotated Frequency Trace of Event [extracted from National Grid Technical Report on the events of 9 August 2019 published 06/08/2019]
