OLE Incident Response

Targeted Assurance Review

15 July 2021

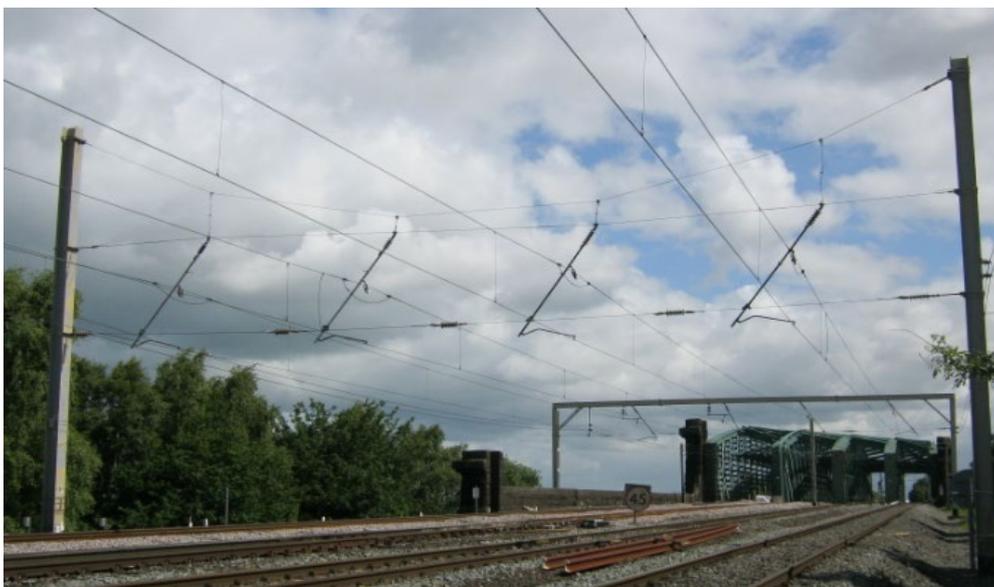
Figure 2.0 – Headspan arrangement

The lack of mechanical independence of headspan OLE structure, which are installed in some part of the network, was also identified as a reason for significant incident recovery time. Failure of the headspan OLE support results in full closure of all the lines it supports causing more disruptions than those structures with mechanical independence.

Variance of the wire support arrangement can be a major factor in determining the severity and impact of damage, and consequently the time to restore after an incident or failure. Examples of OLE support structure include headspans (see Figure 2.0 below), portals, Single track Cantilevers (STCs), and Twin Track Cantilevers (TTCs). These supports differ in track coverage, set up, cost and maintenance requirements. Dewirements in headspan areas can cause more delays, especially where they have been installed at busy locations on the network, because wires supported are not mechanically independent.

Due the limitations of Headspans, they should not be used on new electrification projects. However, there may be economic justifications to use them in low speed and low traffic areas such as depots. Network Rail's policy requirements for electrical power assets (NR/L1/ELP 27000), provides the requirements and conditions for installation of headspan structures.

For existing headspans in station and public areas where failures are of safety concerns, Network Rail plans to upgrade all support and registration equipment to achieve mechanical independence per electrical section by the end of March 2029. They have also set a target of 31st March 2024 to carry out a risk assessment of all the structures. This will be monitored by the ORR at QLMs.
