Learning the lessons: ORR review into Hitachi AT200 & AT300 rolling stock cracking Interim report

09 September 2021

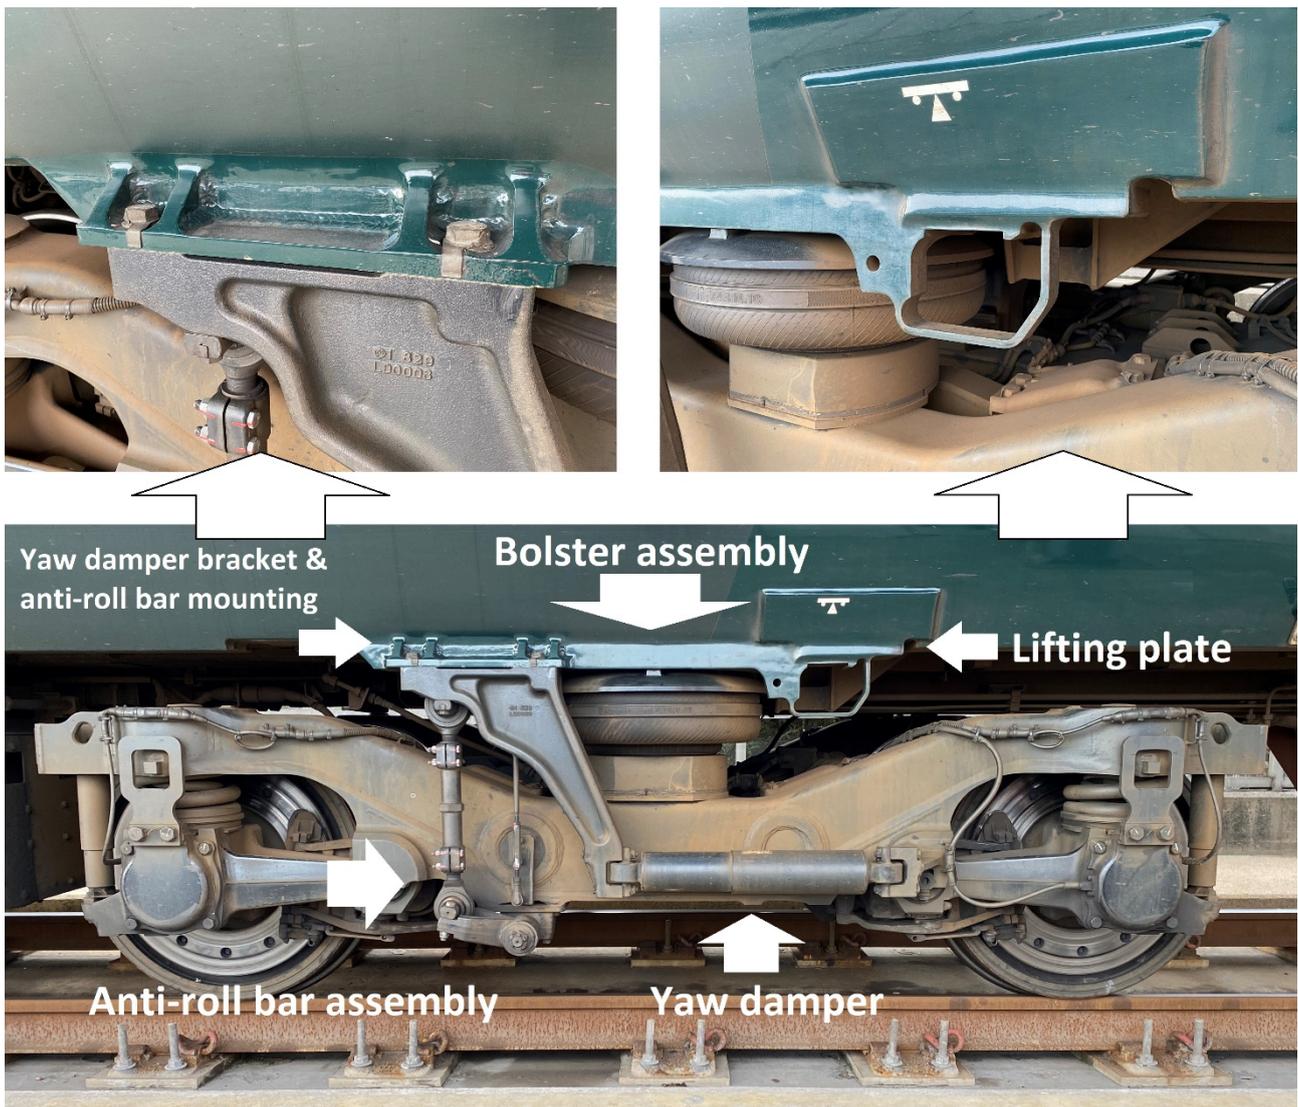
Figure 1: Anti-roll bar & yaw damper connection points, and lifting plate

63. Hitachi produced report OPE-ETR-2021-0053 *AT200 and AT300 Bolster Lifting Point Cracks*, drawing on specialist advice from TWI, subject to updates as the investigation continued. The report confirmed that the crack mechanism in the lifting plate is SCC.

65. The specific corrosive environment for the alloy is considered to be endemic in the UK, arising from high humidity, rain and seawater exposure.
66. The stress input into the SCC mechanism was identified as arising from residual welding stresses. While the bolster assembly was subject to stress-relieving processes following welding, the lifting plate itself was not and therefore retained inherent residual stresses. Service-induced loads in this area were considered to be at such a low level as to be disregarded for the SCC mechanism.

67. The growth characteristics of SCC make it difficult to identify when the cracking occurred, but the initiation was thought most likely to have occurred at the manufacturing stage. Hitachi and its technical advisers have identified no obvious correlation between the extent of cracking and the age or mileage of a train. As the growth mechanism is aligned with the grain structure of the material, propagation beyond the material of the plate itself into adjacent weld areas subject to low stress and composed of a different type of aluminium alloy is unlikely.

69. Engineering Technical Report OPE-ETR-2021-0055 *AT300 Bolster Cracks* records the early technical analysis of the yaw damper cracks found on AT300 rolling stock. The cracks were found to occur in the weld material.

70. The analysis identified a maximum permitted crack length of 200mm for the rolling stock to remain in service.
71. In addition, the analysis considered the consequences of a complete failure of the affected welds which run longitudinally. It concluded that there would be no increased stresses imposed on the transverse welds and no risk of the cracks propagating into the rest of the welded structure.
