# OLE Hot Weather Resilience Targeted Assurance Review

31 August 2021

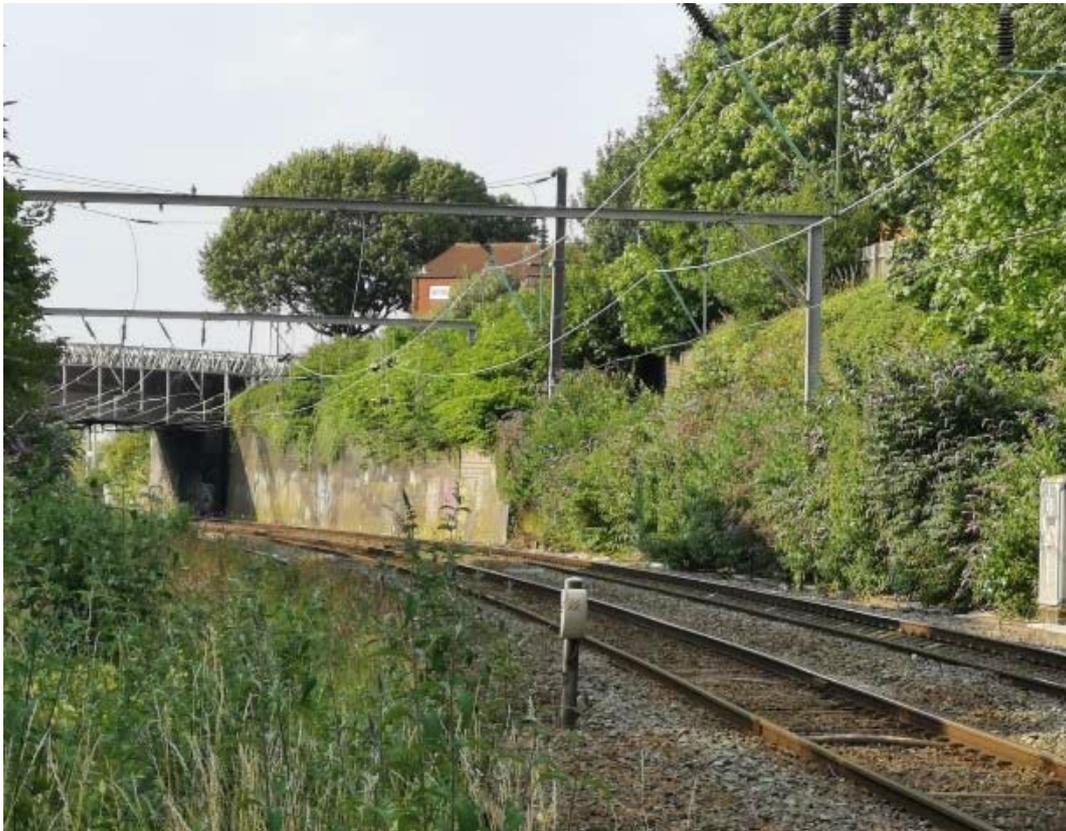
- Fixed Termination Conductor Sag – Unlike Auto Tension equipment, conductors in fixed termination arrangement are unable to automatically readjust their tension to temperature changes. Conductor expansion due to high temperature resulted in significant drop in the wire tension and excessive sag, causing the pantograph to hook over the wire and pull it down or brought the wire into contact with train roof or other non-live parts. These explained most of the incidents in FT areas in 2019. Figure 3.1 shows an example of sagged conductors at Aston, Birmingham. Figure 3.2 shows a detached pantograph head entangled within a fixed termination crossover near Partick viaduct, Scotland in summer 2019.

*Figure 3.1 – Sagging conductors at Aston.*

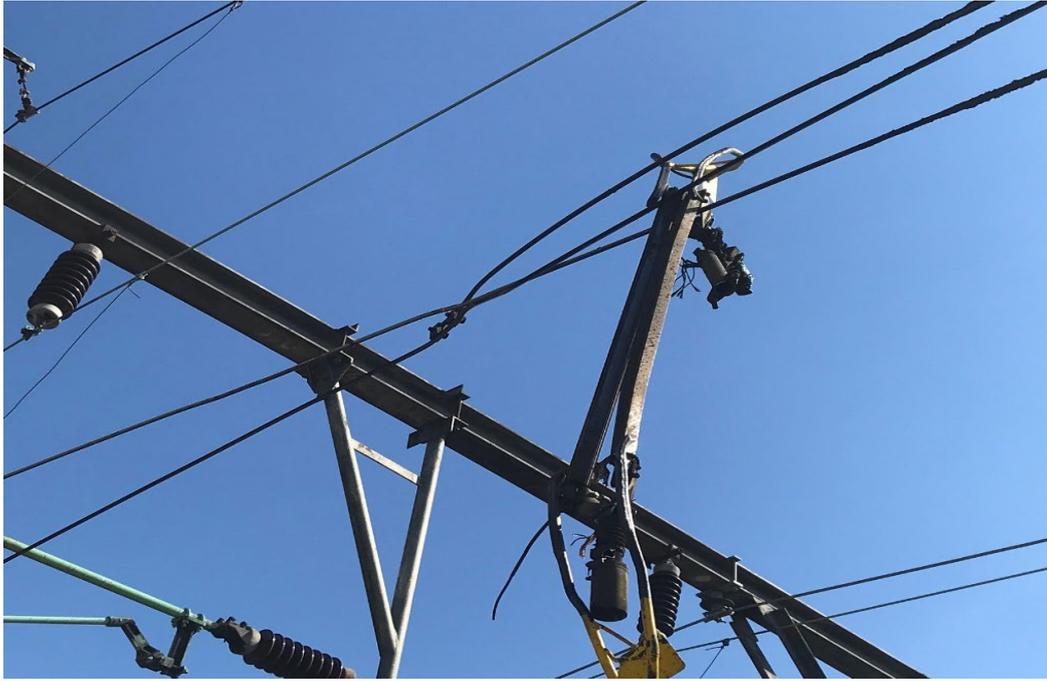
*Figure 3.2 – Detached and entangled pantograph head at Partick Viaduct.*

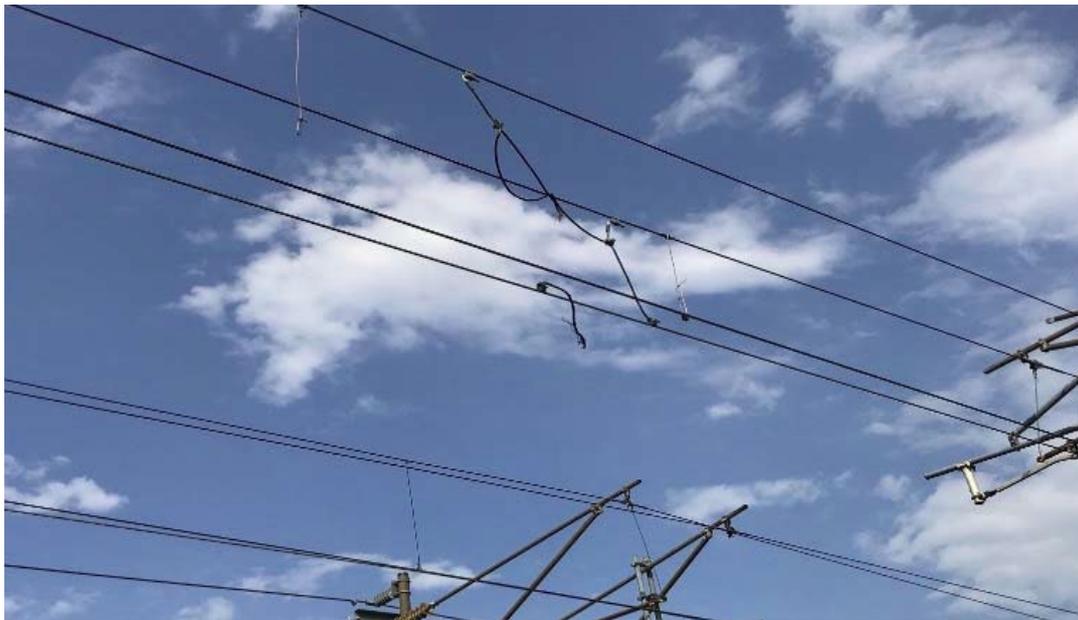
- Heat-induced excessive conductor expansion at overlaps – The hot temperature caused conductors at overlap to stretch beyond normal; resulting in excessive sag of outrunning wire and excessive differential movement of adjacent wire runs. This further led to pantograph hooking over sagged wire or overlap jumpers disconnecting after being overstretched. Figure 3.3 and Figure 3.4 shows some examples of incidents caused by broken jumpers.

*Figure 3.3 – Stretched jumper at overlap hanging foul of vehicle gauge.*

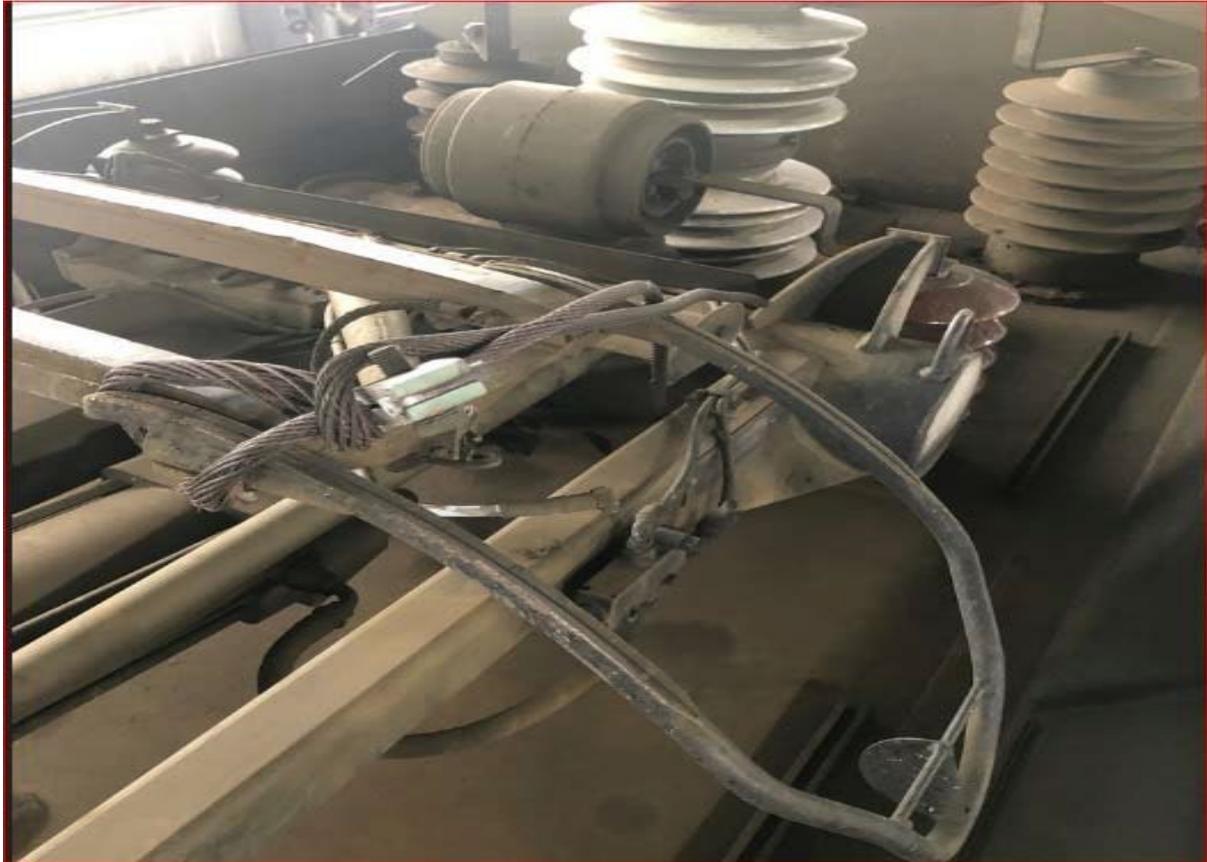
*Figure 3.4 – Disconnected jumper wrapped around pantograph horn.*
