# Network Rail Track Renewals in Control Period 4

Site Inspection and Review of items proposed for renewal on Primary Routes in 2009/10 to assess the justification for the timing and the proposed engineering specification.

Richard Spoons Associates Ltd

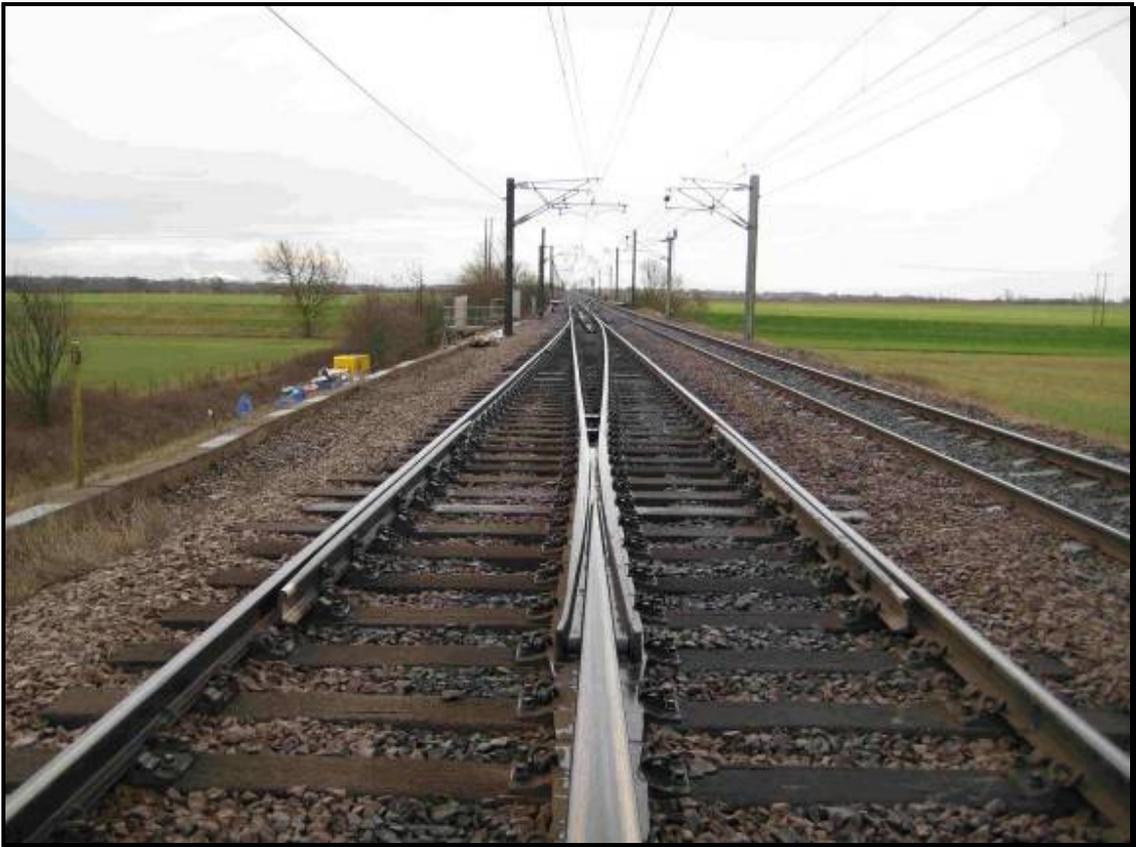
Figure 1 Templehirst Junction looking south

The junction was installed in 1981 when the original route of the ECML between York and Doncaster was rebuilt to the west to allow coal to be mined under the old route. The bearers are hardwood timber, now showing evidence of delamination, and rails 113A flat bottom. Over 50% of the ironwork has been replaced with evidence of refurbishment in 2002. The driver for renewal in 2009/10 is the quality of the geometry, which is poor, and this is leading to the likelihood of component failures. The ballast is heavily contaminated with coal spillage. During the inspection a broken insulated stretcher bar was found and reported. Renewal in 2009/10 will result in an asset service life of 29 years. The existing crossover sits on an underbridge. This contributes to the geometry problems due to the irregular stiffness of the sub-base. The

None. The current poor track geometry and difficulty maintaining satisfactory geometry for 125 mph operations due to the coal dust contamination in the ballast, any deferral beyond 2009/10 will result in further component failures and a consequential impact on performance and maintenance costs.

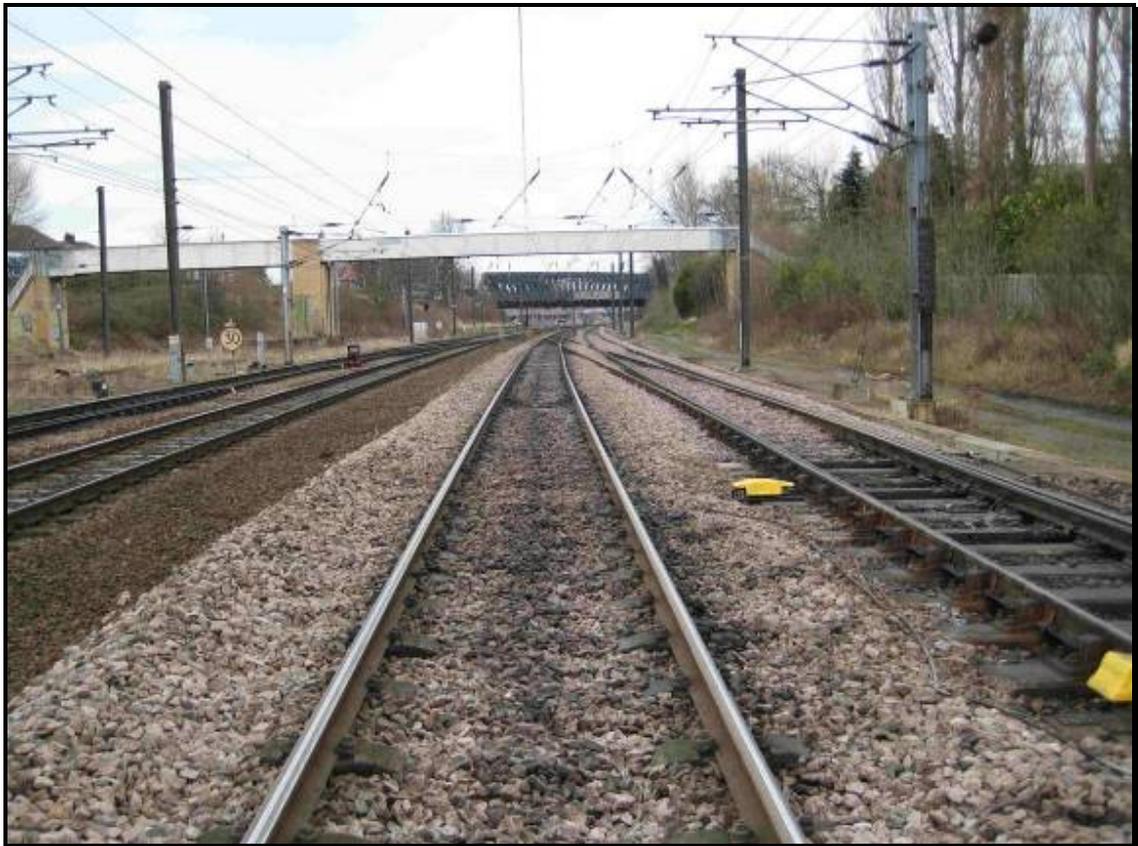
**Figure 2 Down Fast at Holgate. North end of site looking towards York Station**

The category 3 track carries over 13 equivalent million gross tones per annum (EMGTPA) and was installed in 1964 with the now obsolete AD fastenings and also obsolete F14 concrete sleepers. The 110A rail condition is not good and it is the age of rail that is driving the renewal. The track geometry is satisfactory despite dirty ballast. Records show that the ballast was renewed in 1989.

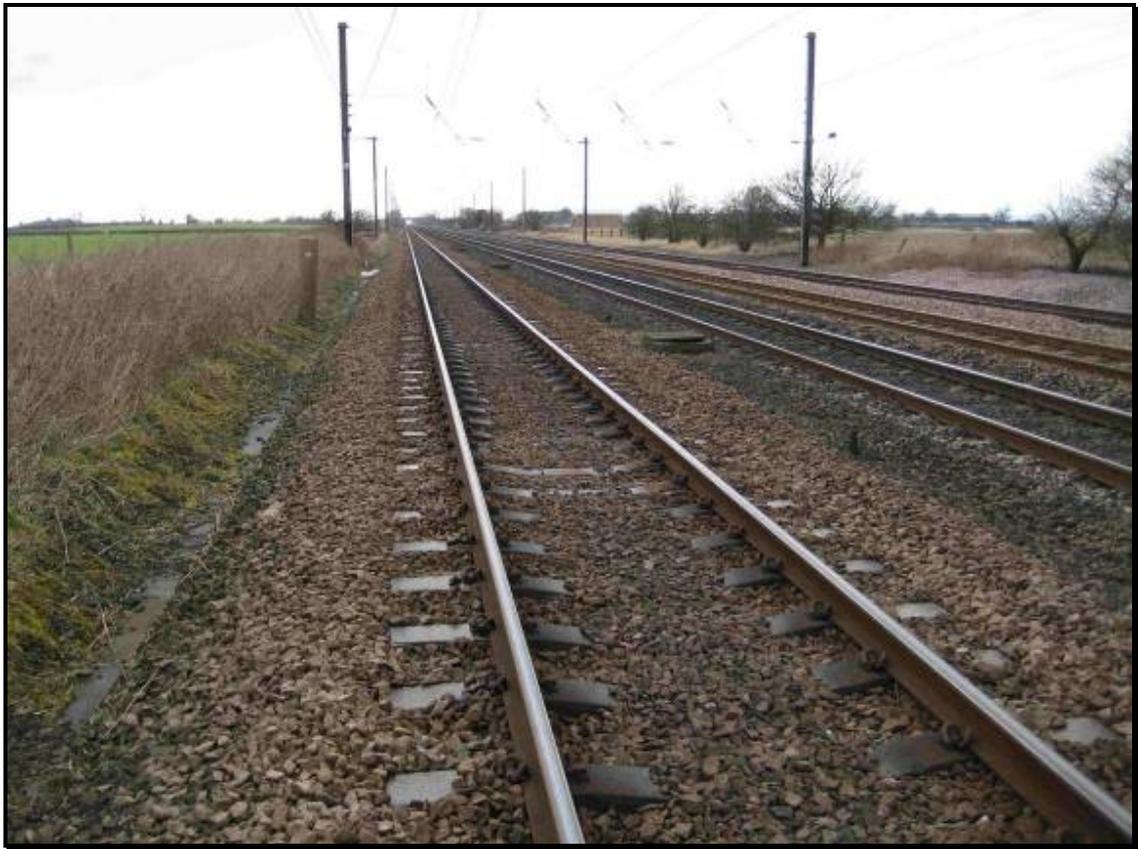
**Figure 3. Down Slow at Beningbrough**

After the inspection a detailed rail failure report was provided, confirming that rail renewal was now due.

The expected life of the sleepers is 45 years. There was no evidence of sleeper deterioration, leading to an expected sleeper renewal year in 2017. It is therefore suggested that the specification for this site be changed to rerail only in 2009/10 and treat the poor top by maintenance with stoneblower.

The current specification could not be justified. The site inspection leads to a recommendation to renew the rail in 2009/10, but defer the reballasting. The rail defect history was provided and showed the detection of 22 removable defects in the last seven years. Deferral of the reballasting into CP5 would make this a potential ballast and sleeper renewal item, which is considered to be a more efficient means to manage the asset life of this particular site.

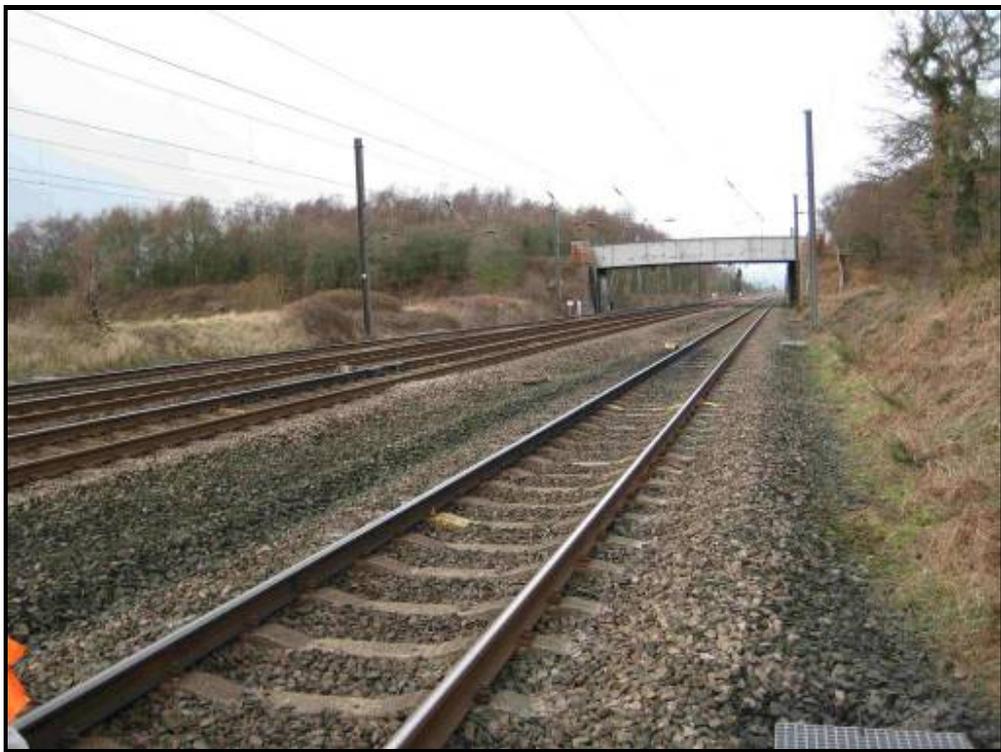
**Figure 4. Up slow at Pilmoor**

This stretch of the up slow was installed in 1959. Most, but not all of the 1959 rail was replaced in 1979. The track type is the same as that at Holgate. AD

fastenings on F19 concrete sleepers. However, here, the fastenings are in a very poor condition and there are several of the F19 sleepers with cracks through the holes for the fastenings. Just south of the photograph the line curves gently to the east. Here the fastening condition is not as good as the straight. Maintenance work will be required before the track is renewed in 2009/10. The driver for the renewal is the condition of the fastenings. At the York end of the 1959 sleepers is a short length of 1970 F27 sleepers that but up to F40 cwr laid in 1990. It makes economic sense to renew this short length of track (137 yards) at the same time.

None. The fastening condition is such that deferral should not be considered.

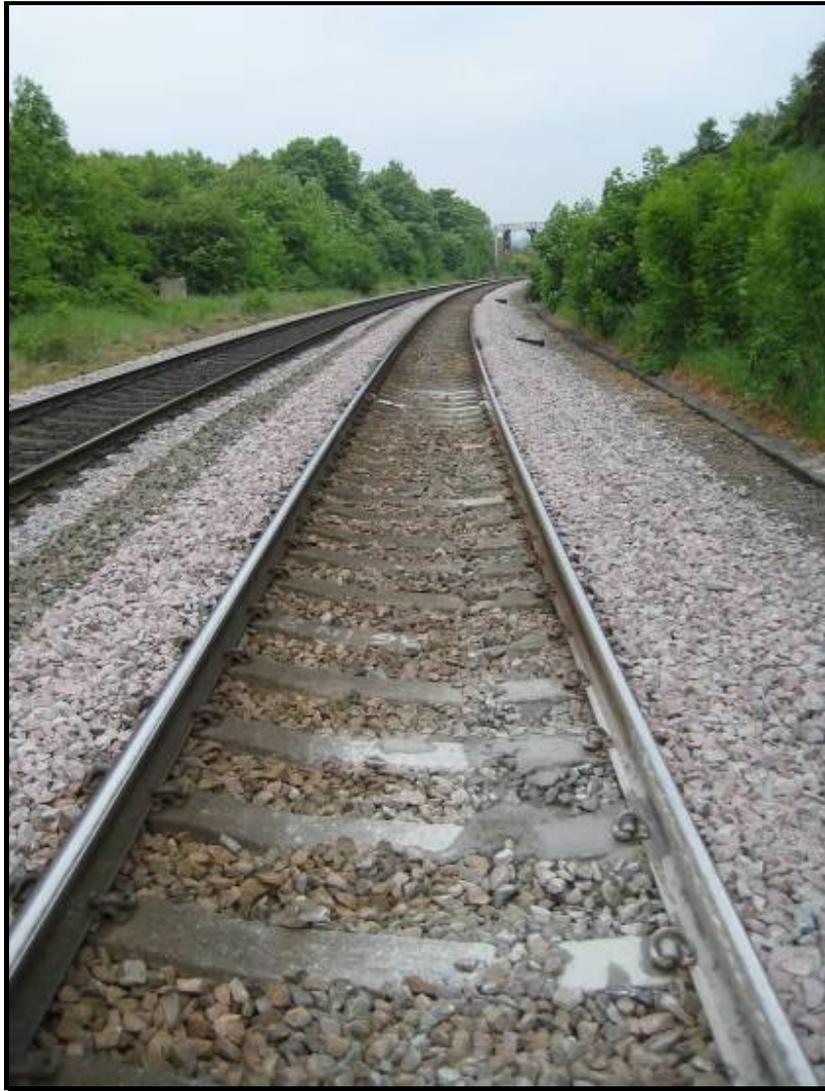
**Figure 5. The up main, south of Market Harborough, clearly showing formation failure**

The proposal is for reballasting, formation renewal and lineside drainage on the up main from 82 m 268 yards to 82 m 980 yards in 2010/11. The rail was renewed in 2000, most likely as a result of rolling contact fatigue, and the sleepers appear in good condition although they are a variety of F23, F27 and EF33. Track geometry varies throughout the site, there being some poor top and line at 82¼ mp and again at the northern end of the site (82½ - 82¾). The existing cess drain was flowing, and there was evidence of earlier formation renewal and the use of shallow depth sleepers. Network Rail's notes state that part of the site was reballasted in 1997. If this is so, then, without formation treatment and care in producing water gradients from the ballast/formation interface to the existing drains has resulted in the need for the correct engineering solution to be applied 13 years later. The line at this location has a maximum permissible speed of 75 mph.

From site inspection, and scrutiny of the last 12 months of recorded track geometry, further investigation should be undertaken northwards from 82m 830y to the fronts of the trailing connection in the up main to determine the root cause of the poor geometry. If this is associated with the formation and drainage conditions, then the work proposed should be extended. If there are other reasons then appropriate maintenance work should be arranged.

None. The current poor track geometry and difficulty in maintaining satisfactory geometry, even for 75 mph operations, due to what appears to be an inability of water to leave the track and enter the drainage system, will lead to difficulty in preventing possible condition of track speed restrictions if not treated in the early part of 2010.

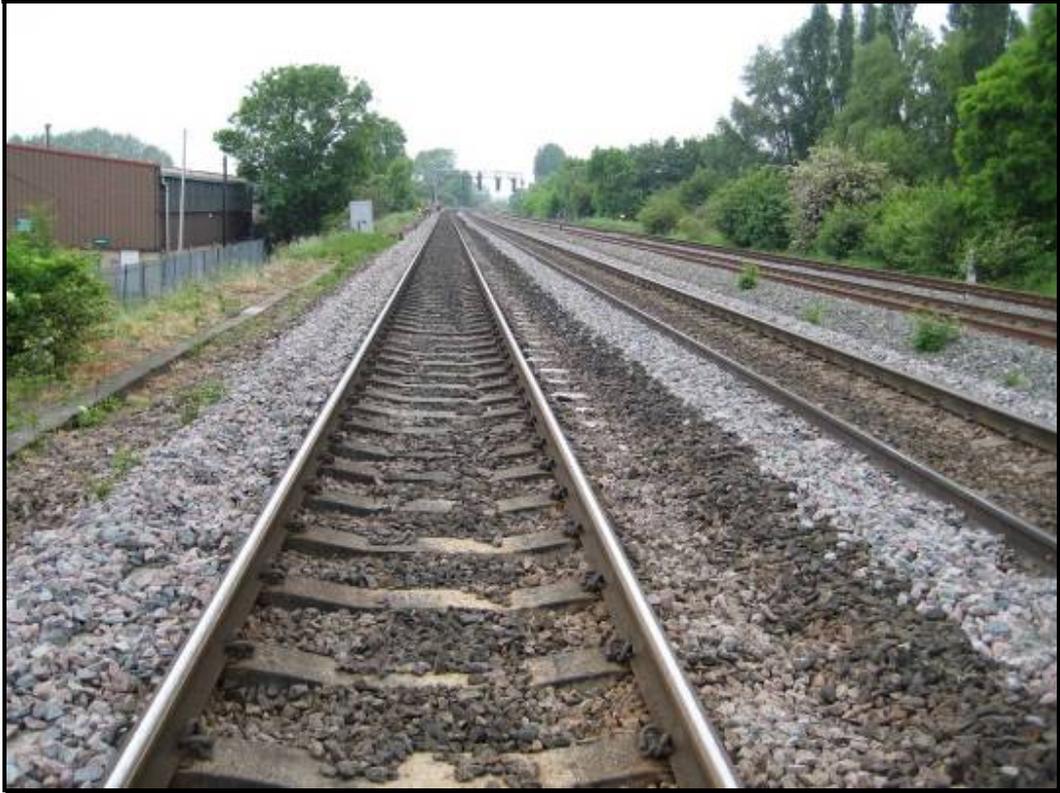
**Figure 6. Kettering. View looking north from the four foot of the down main at the southern end of the site. 71 MP in the mid distance. Slow lines to the right.**

The track was installed in 1972 with 113A cwr; F27 sleepers and 401 pandrol fastenings. 7.5 mm pads were installed in 1995. The adjacent up main is the same age. Ballast conditions look good on the surface; however, trial holes have revealed an old formation treatment with Terram sheet overlaying sand. at the south end where there is an old drainage system leading up to and through overbridge No. 55 at 70m 1480y.

The ballast conditions are not exceptionally bad, even though the trial holes only show localised failure of the sand/Terram treatment. Therefore improvements to the geometry should be possible for the two eighths of a mile that are in the poor and very poor categories by using a stoneblower. Similar maintenance treatment to the adjacent up line is also recommended.

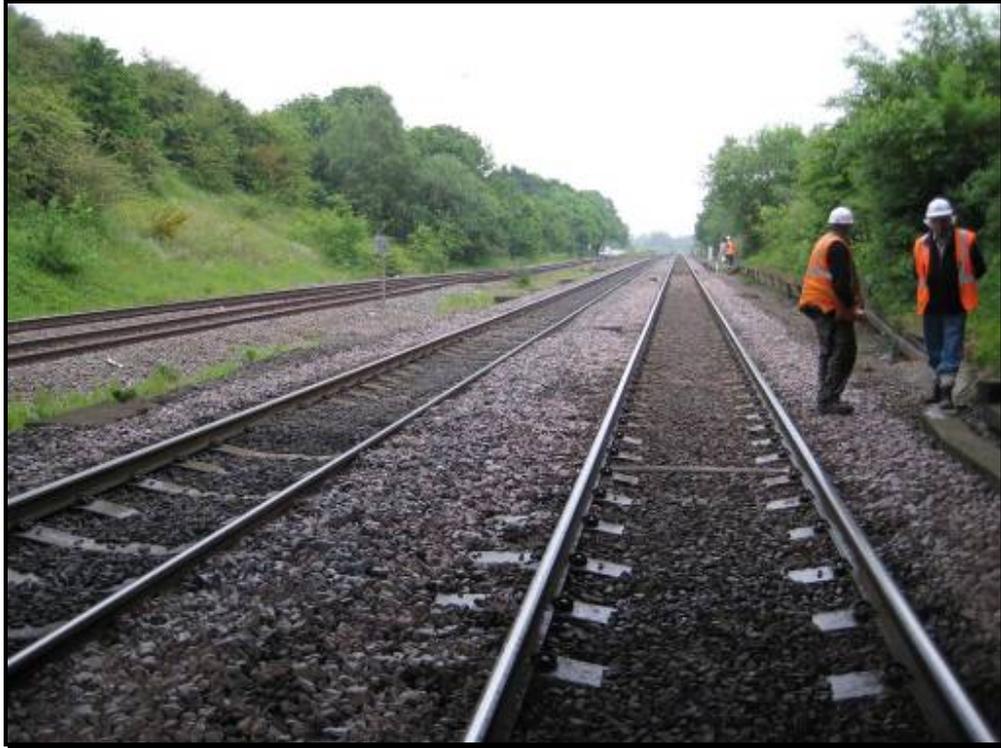
**Figure 7. Kettering. View looking south towards Kettering South Junction. Note the existing drainage manholes in the up cess, six foot and down cess.**

It is recommended that a detailed track drainage scheme for both up and down lines is designed with associated formation treatment, particularly from the S&C and through the overbridge. When this is ready for implementation renewal of the rail, sleepers and ballast is justified from the S&C and up to the 1990 F40 cwr at 71m 30y on the down line. A separate proposal for the up line should be considered for later in CP4 such that its renewal and associated formation treatment will tie into that constructed for the down line.

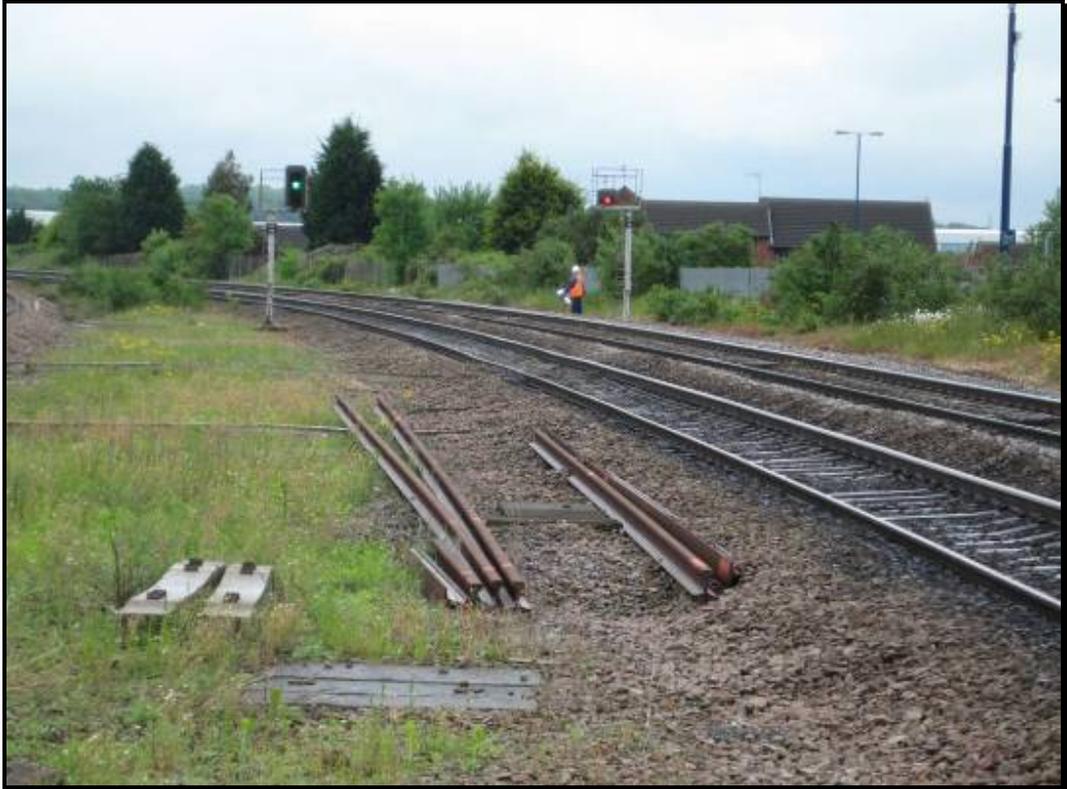
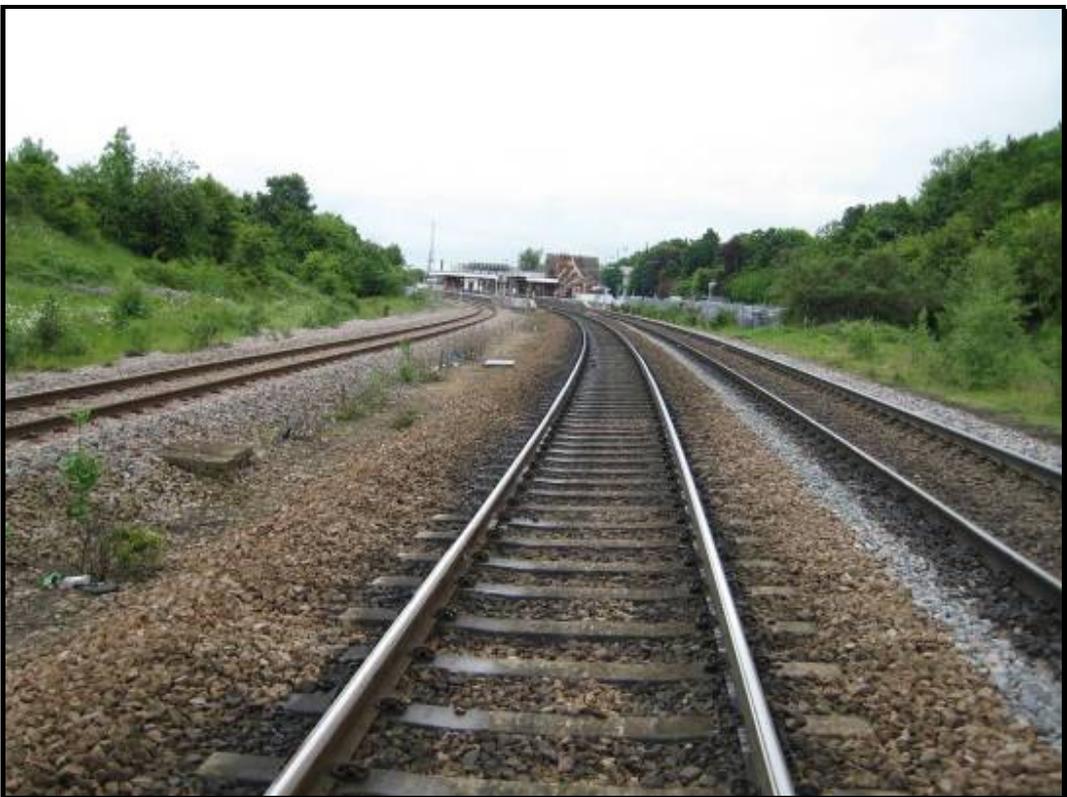
**Figures 8 and 9. The line curves to the left as trains leave Wellingborough for Bedford. The up main is nearest to the camera. Below. The up main line approaching Wellingborough station from the north.**

Track geometry data over the last 12 months shows track generally in the satisfactory band. The only exceptions are a specific twist defect just south of the station (which can be seen in the centre of picture 4) and the length of straight track between the north end of the curve through the station and the next curve in the opposite direction which commences at 65m 800y and includes a trailing and facing connection from the up and down slow line. The long wave top and alignment is of lower quality through the platforms. This may well be partly due to the poor drainage and partly due to constraints in lifting and sluing when undertaking geometry maintenance with stoneblower.

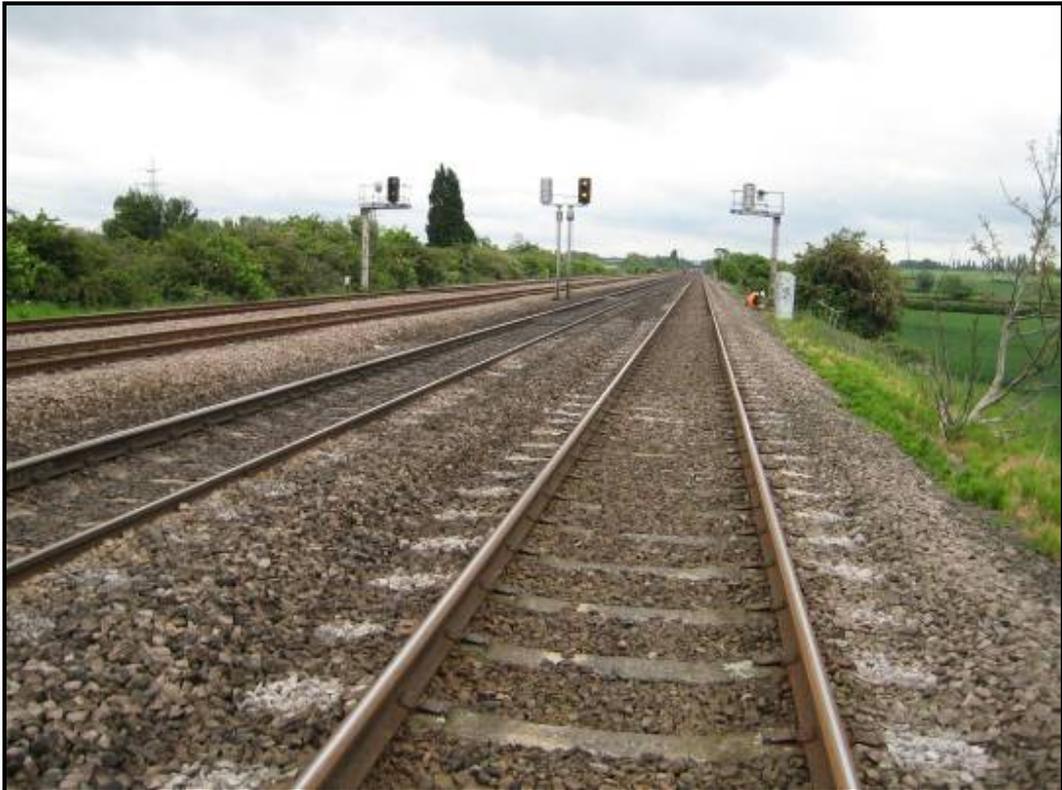
**Figure 10. Down Main at Clapham. Note voided sleepers, indicative of extending machine maintenance intervals too far.**

This stretch of the down main was installed in 1966; however the rails were renewed in 1991, except between 52m 340y and 52m 737y, where 1966 rail is insitu. The fastenings are SHC and sleepers F19. The track geometry records show either good or satisfactory bands for all four top and alignment parameters. Ballast is dry but crushed with fines. Maintenance is by stoneblower. Many sleepers are slightly voided. This has the consequence of accelerating the wear between sleeper, pad, rail foot and fastening, resulting in reduced tension that can lead to rail movement in extreme hot and cold ambient temperatures between night and day.

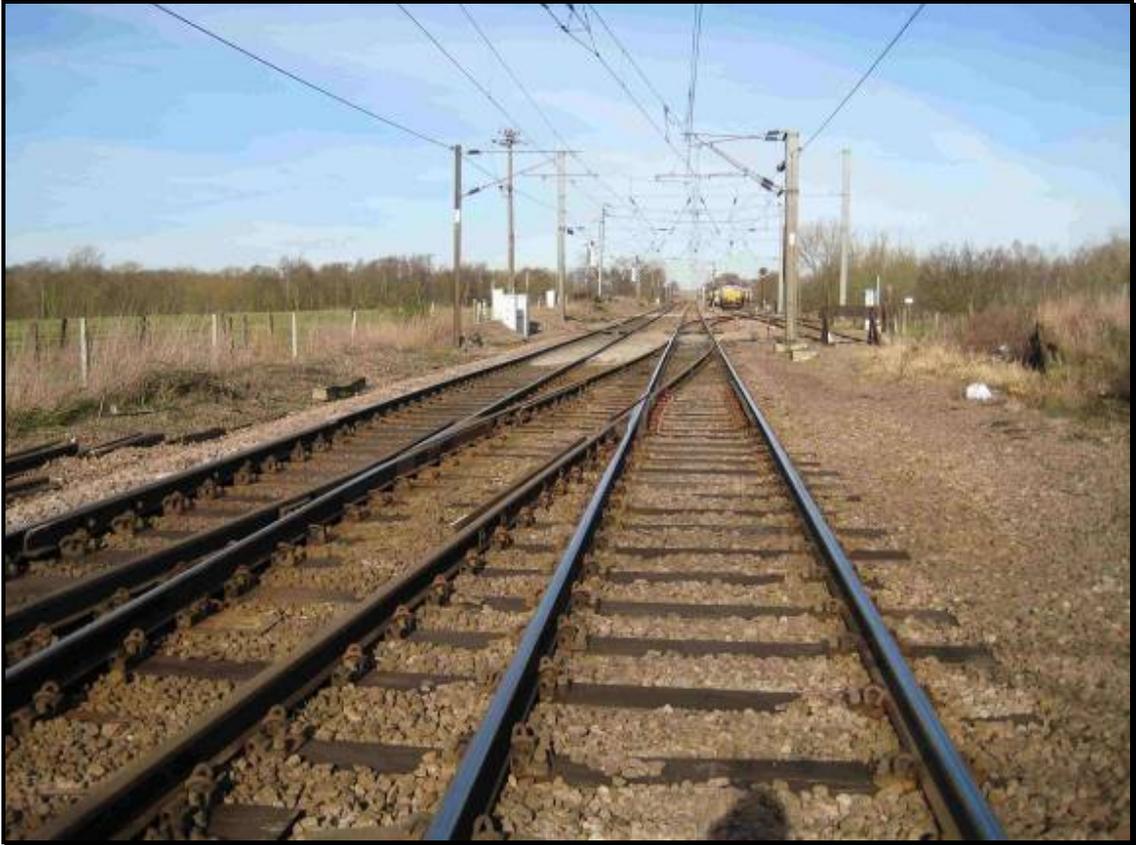
Figure 11. Barham S&C looking north from the fourfoot of the up fast

As the photograph above shows the layout sits on a good straight track alignment. The one engineering condition that does give concern is the ballast and sub base. A failure of the formation on the down main has occurred opposite the up main facing switch. Also there is evidence of several years of work digging out dirty and fouled ballast. The track geometry recordings on the up and down main lines show that the values of standard deviation for 35m chord top exceeded 4 (poor) at the end of 2000. Repairs were carried out however intervention is necessary once per annum to hold the geometry

in the satisfactory band. The renewal specification is for a like for like replacement with 113A rail and concrete bearers. This is supported in order to minimize cost and take account of the improved reliability of the track system due to its alignment and reduced utilization. The site investigation report specifies formation treatment to improve track bed stability. Further benefits are available by removing the overburden on the embankment cesses.

One option for this site would be to undertake life extension of the track system using a proven technique such as that developed by Sersa. This would only defer the renewal into CP5 due to the formation and ballast condition. Modelled life of S&C in cat 2 track with 15 EMGTPA is 35 years.

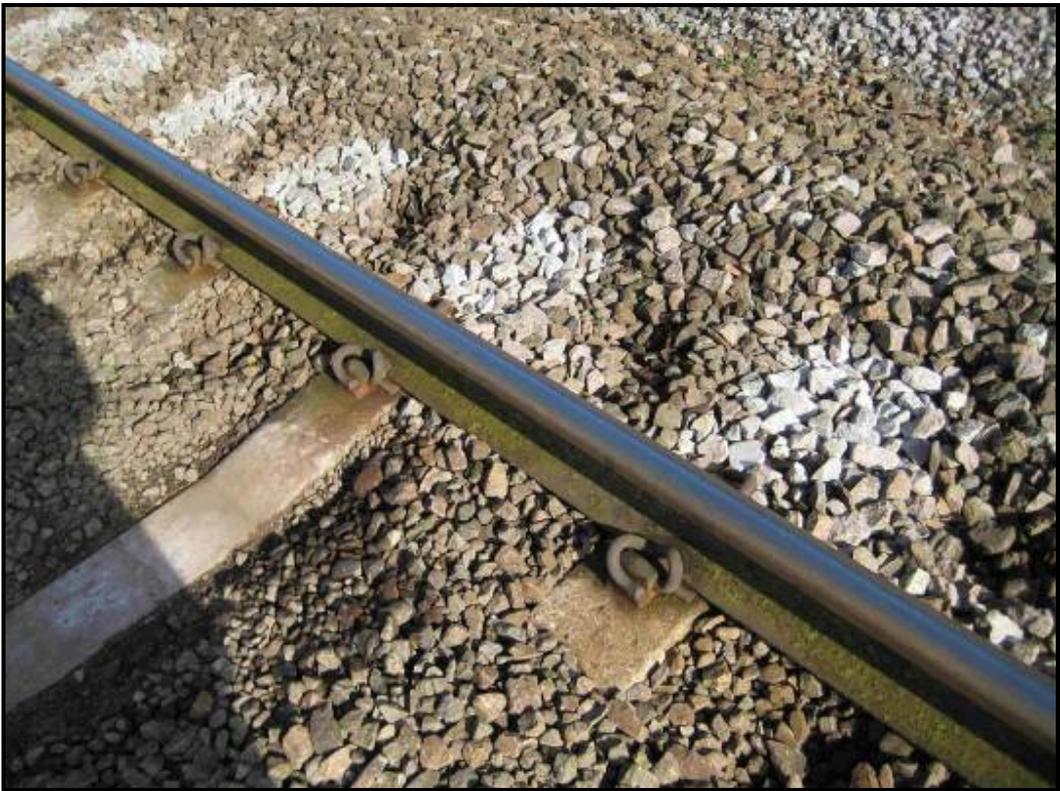
**Figure 12. Down line Barham showing the problem with slag ballast used by BR in the 1960's**

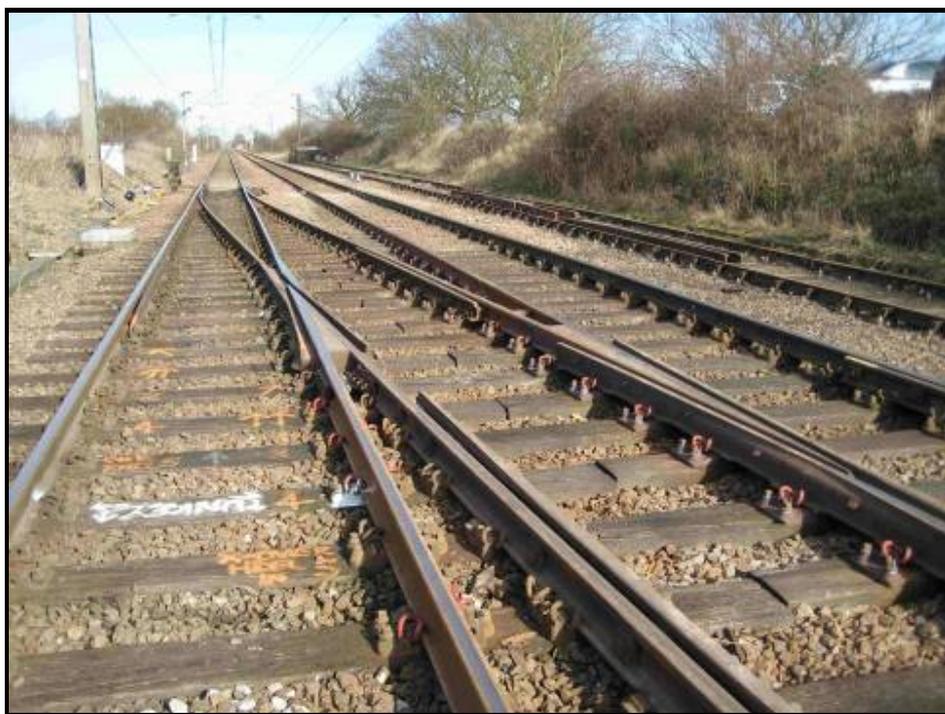
**Figure 13. Diss S&C and up siding from the down main line looking north**

It was noted that some replacement ironwork had been ordered and was lying in the sidings area. This layout is ideal for life extension treatment.

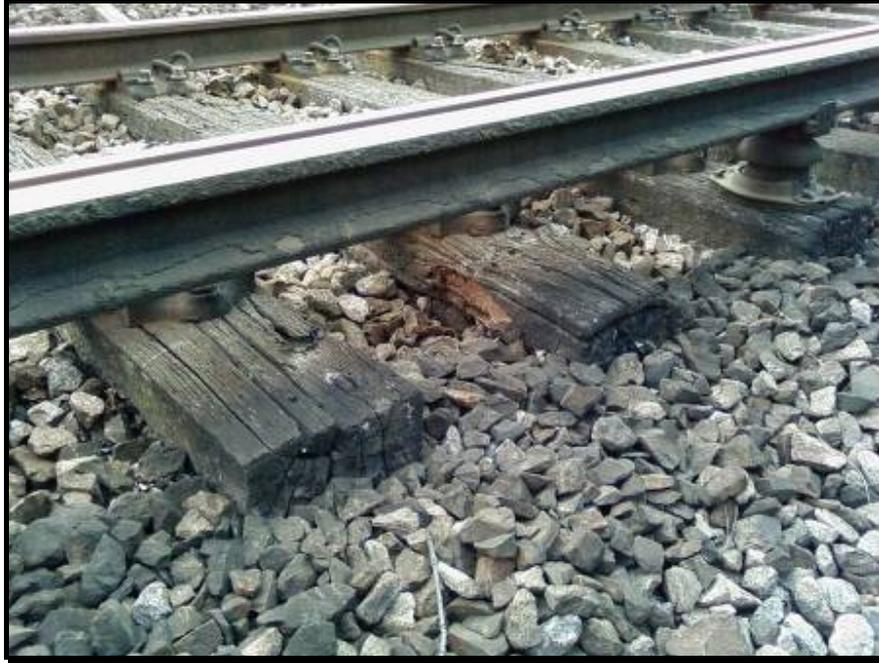
Figure 18. General sleeper condition at Surbiton is very poor.

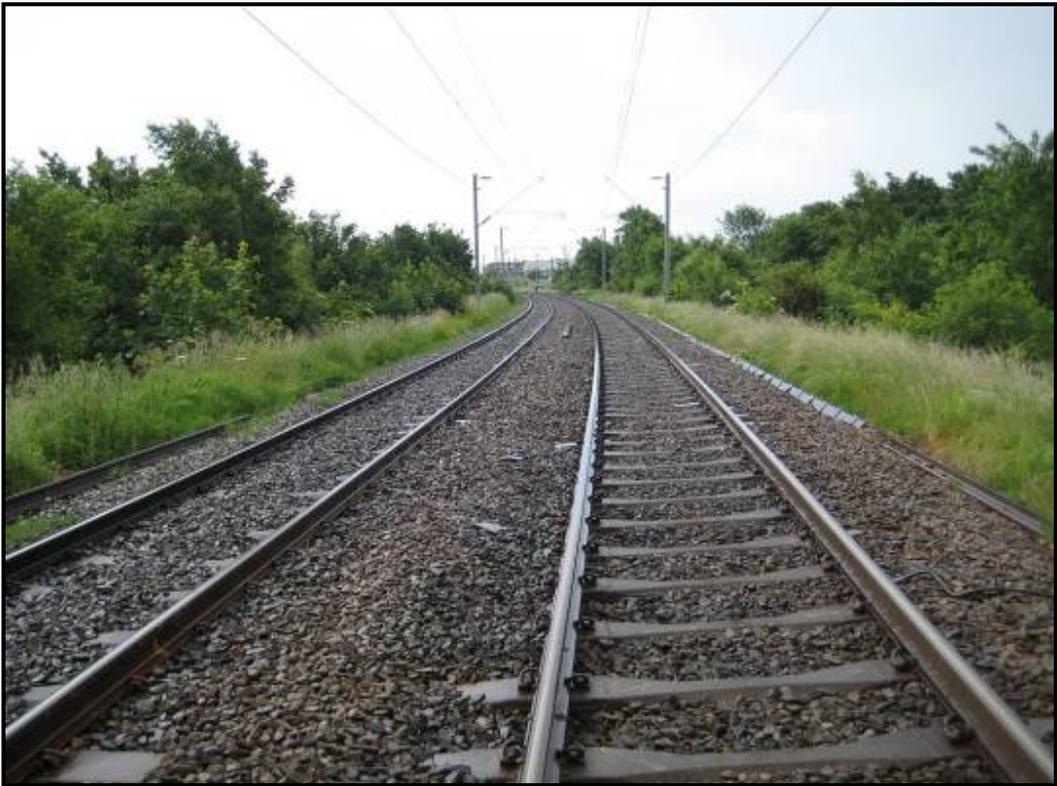
**Figure 24. Down line looking towards Wolverhampton North Junction from approximately 13m 1100y.**

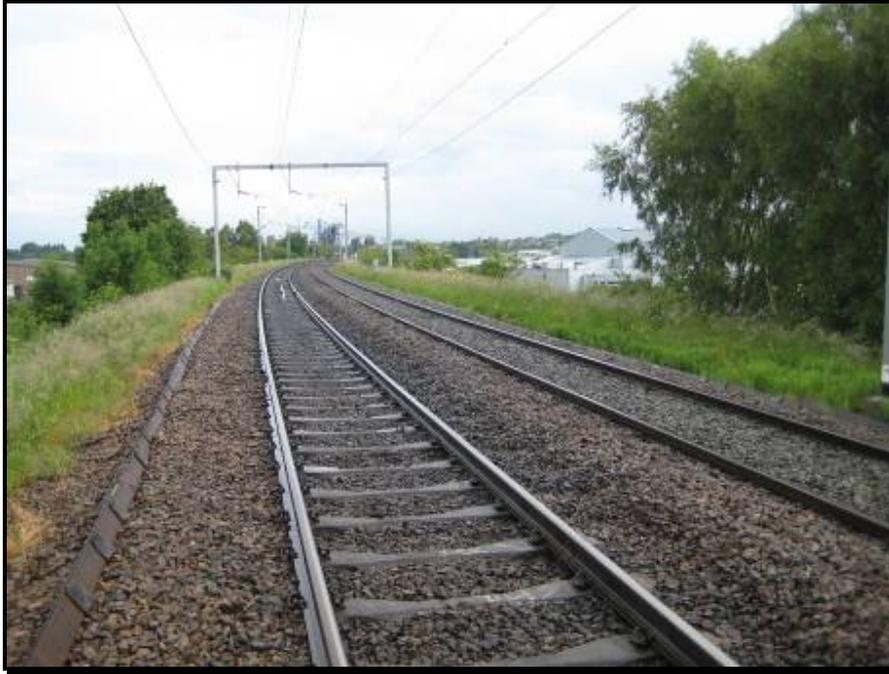
**Figure 25. View from the down line looking towards Bushbury viaduct. Note old rails in both cesses from maintenance rerailing due to sidewear.**

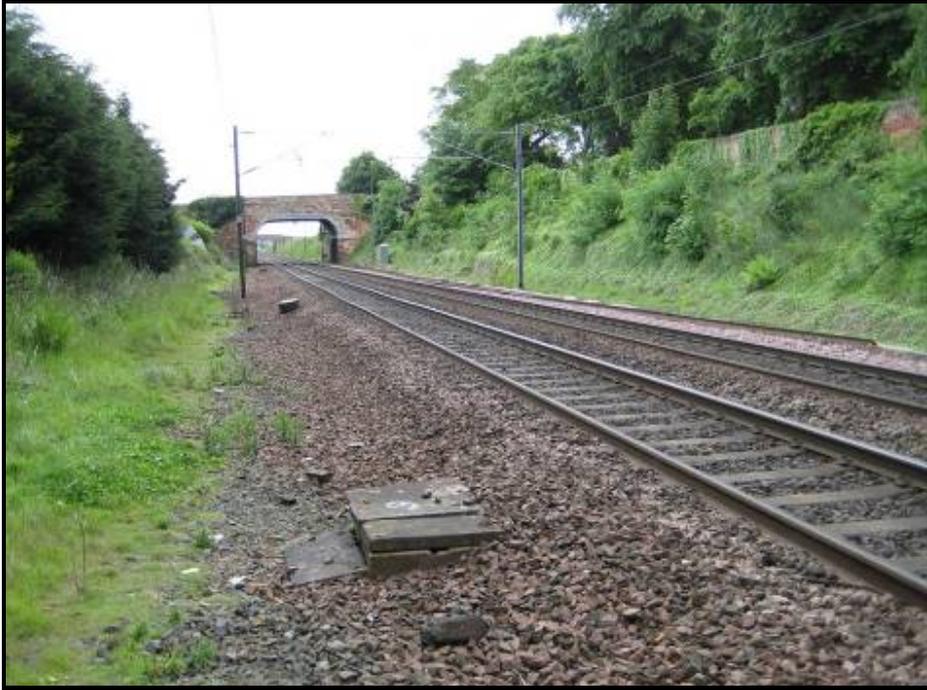
Figure 35. Monktonhall looking east through the site of the former Inveresk station, showing cess drains and poor top through overbridge 29

The recommendation for this proposal is 1) urgently undertake an soils investigation through the old station and overbridge 29 to define the type and extent of formation treatment necessary; 2) carry out this work and the track renewal from 6m 575y to 6m 845y in 2009/10; 3) renew from 6mp to 6m 575y later in CP4.

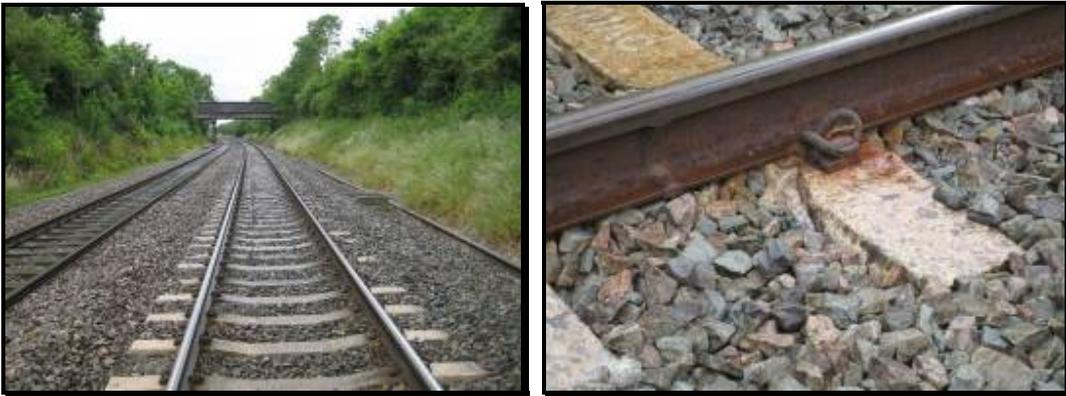
**Figures 46 and 47. Defford down line looking north (21) and damaged concrete sleepers from a derailment many years ago (22). The formation problems are in the vicinity of the overbridge.**

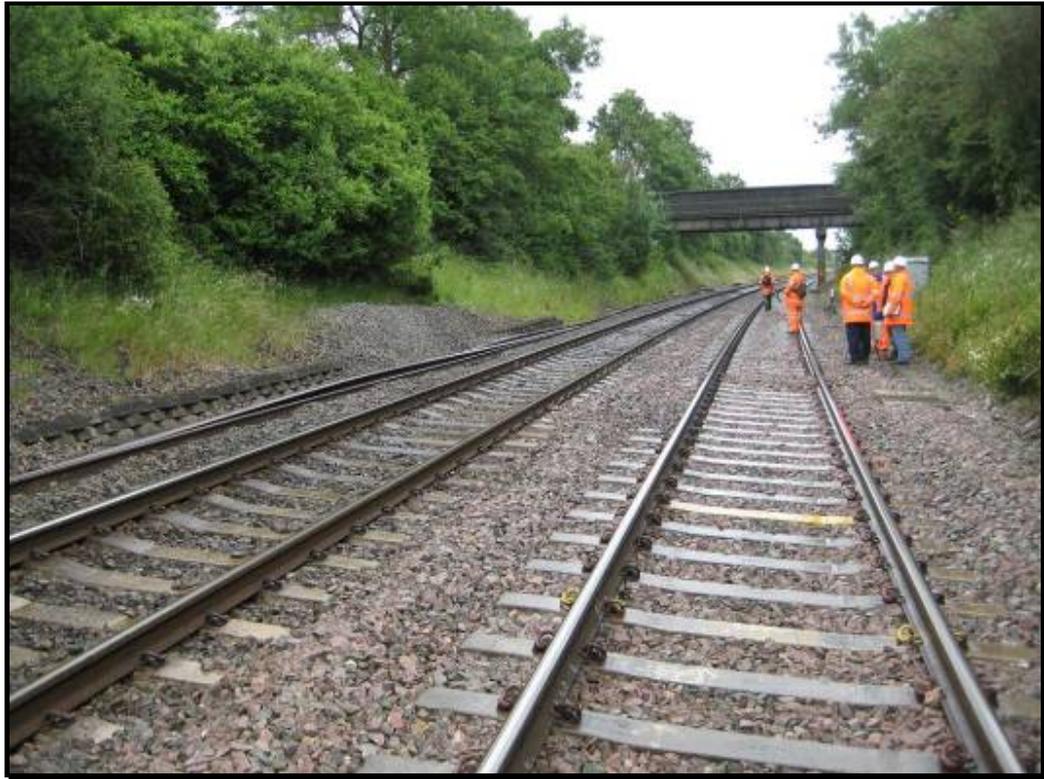
**Figure 44. Defford. View of the down line from the up showing evidence of manual repairs to the slurried ballast where the drainage system has broken down.**

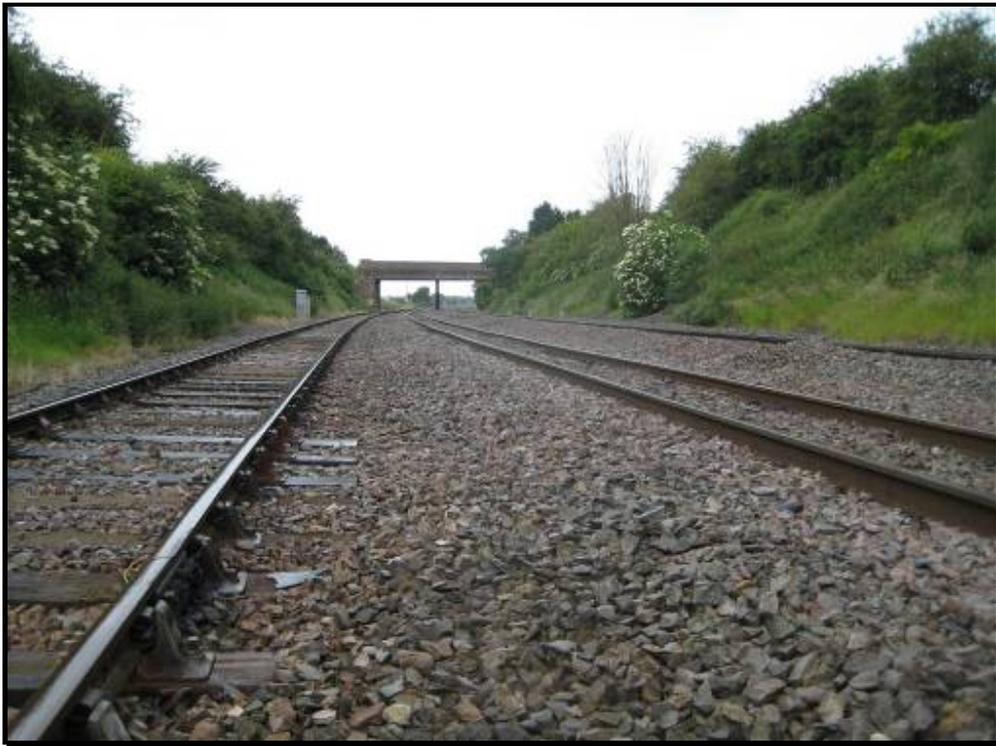
**Figure 45. Crawfords Down line looking south showing poor top.**

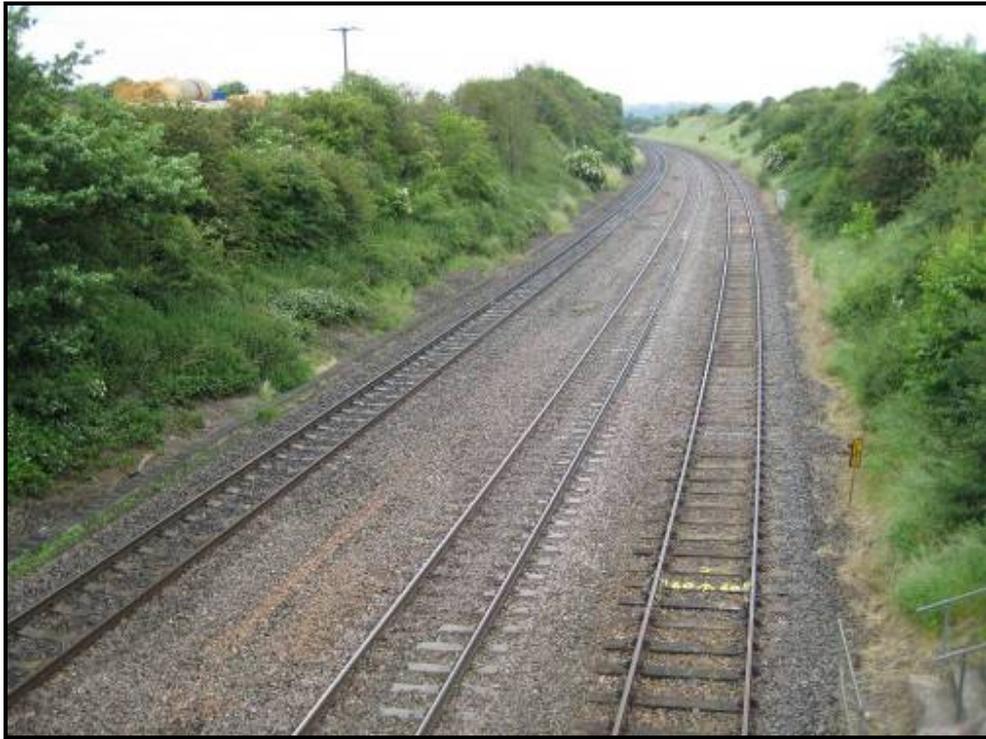
Figure 46. Picture 25. Crawfords from the overbridge looking north. Note the new cwr in the foreground and the drainage in the ten foot.

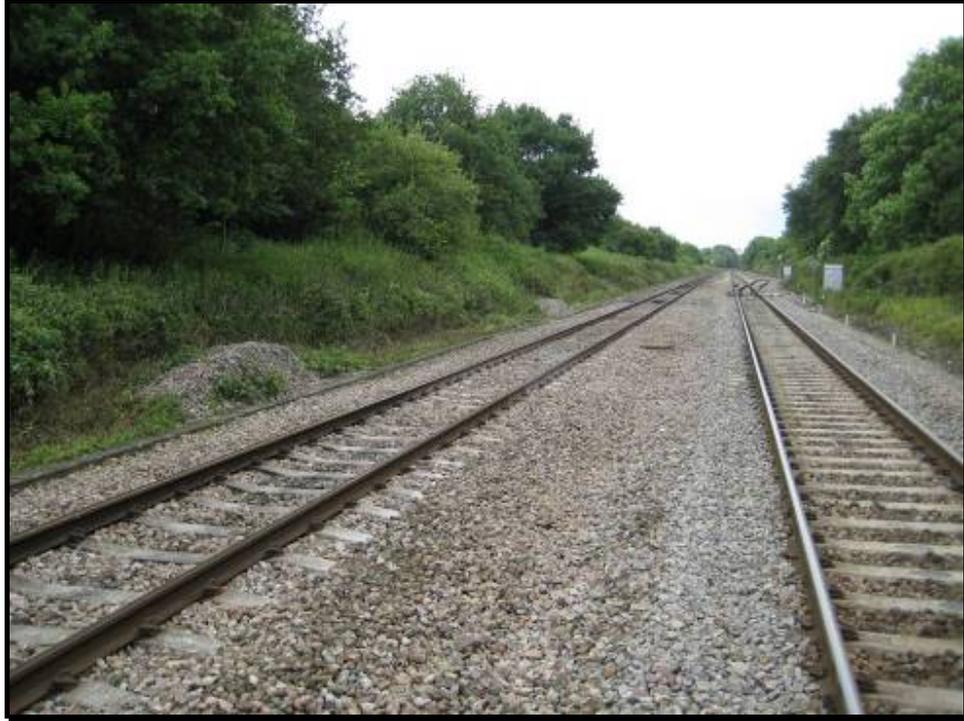
**Figure 47. Picture 26. Prouts Bridge up line from 99m 580y towards 99m 220y showing poor top and evidence of manual removal of slurried ballast.**

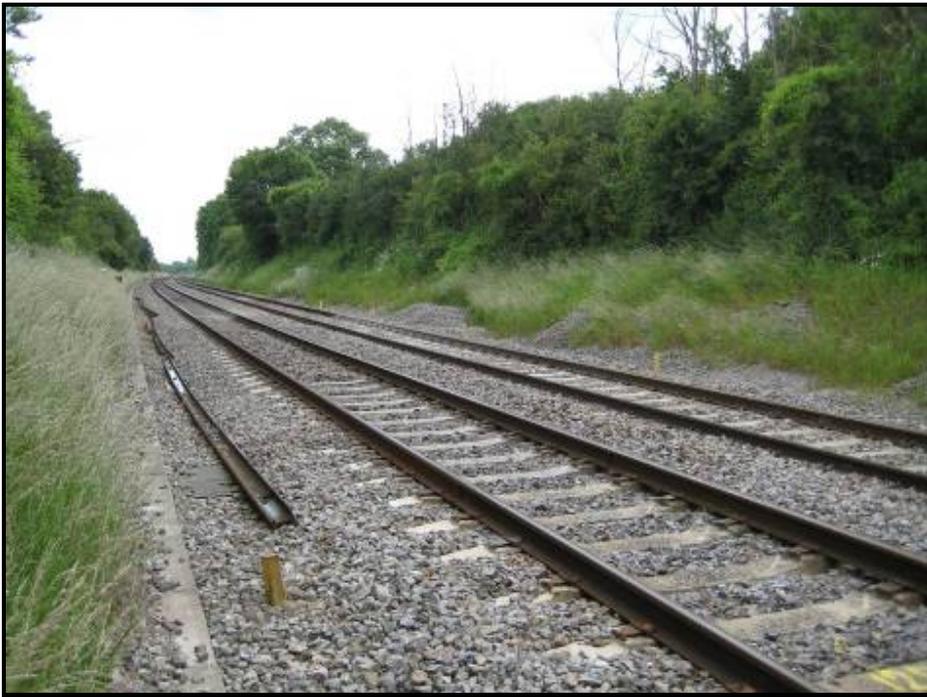
**Figure 48. Both tracks are proposed for renewal. The up line is in the foreground. Note the evidence of manual treatment to the slurried ballast on the down.**
