Oliver Stewart Senior Executive, RAIB Relationship and Recommendation Handling Telephone 020 7282 3864 E-mail oliver.stewart@orr.gsi.gov.uk

8 April 2019

RAIB Report: Passengers struck by a flying cable at Abergavenny (Y Fenni) station on 28 July 2017

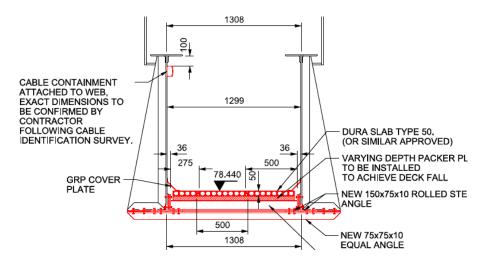
An interim containment system has been implemented, clamped to the top chord of the parapet. A full refurbishment of the footbridge is currently being tendered, which will incorporate covered containment on the inside of the parapet, permanently removing the risk (proposal shown on image below).

5. Network Rail are refurbishing the footbridge at Abergavenny station which will include secure containment of cables being carried over the railway. We are satisfied that the refurbishment will provide appropriate support for the cables and reduce the risk of a similar incident happening again. The work is expected to be completed by the end of April 2019 and open for public use by 4 May.
