**RAIB Report: Collision between a train and a tractor at Oakwood Farm User Worked Crossing, Knaresborough, 14 May 2015**

## Recommendation 1

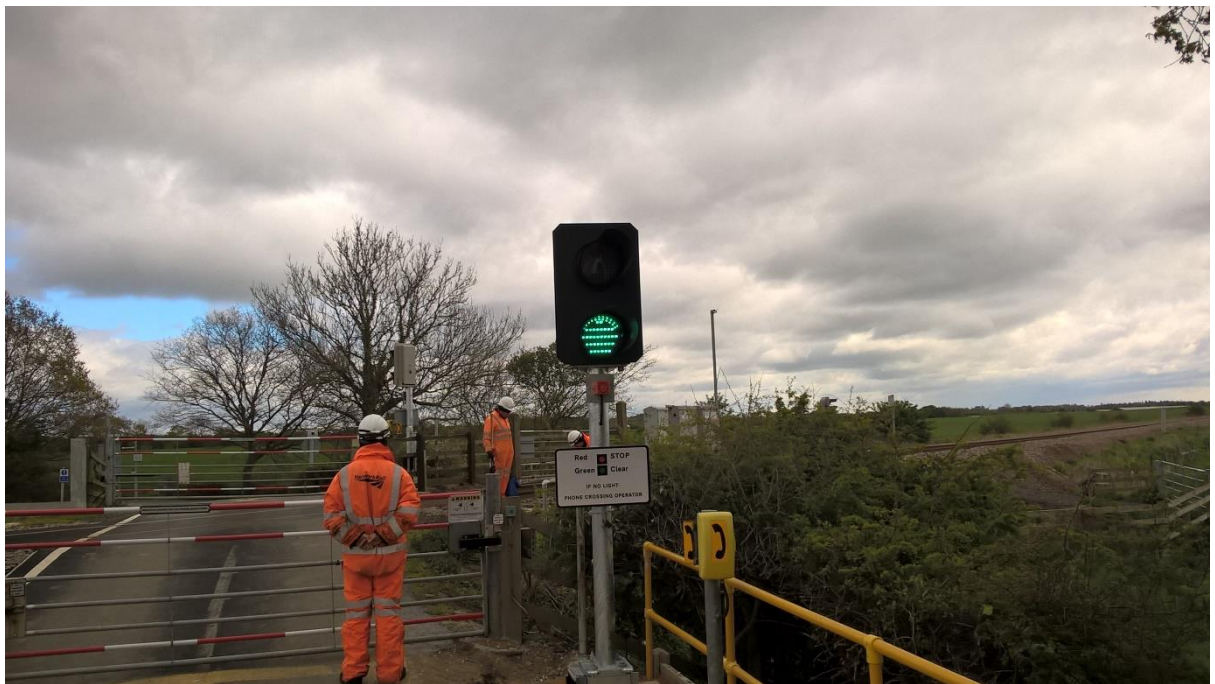
*Network Rail has implemented the actions required to improve the crossing, those of which not taken forward were dismissed as part of the HAZID for POGO. Photographs provided as supporting evidence to show the improvements made.*

- 1. Increase the size of the RTL lights – implemented*
- 2. Provide duplicate RTL lights on the opposite side of the crossing – not implemented as we have replaced the existing lighting units with larger aperture lights improving visibility on the approach, the improved visibility has been confirmed by the RLCM and a signal sighting engineer (who we used help agree the best alignment) and also by the Authorised user.*
- 3. Provision of the universal User Worked Crossing sign – signage is not in use in the UK and could cause confusion*
- 4. New Detailed Instruction Sign – implemented*
- 5. Red and White Markings on the gates – implemented*
- 6. Red target on the gates – not implemented as the red target has a specific meaning in railway signalling, which is for gates that swing across the railway. These gates do not swing across the railway. However; we have taken*

*measure to improve the visibility of the gate a night by applying retroreflective tape to gate, which meets the requirement of this recommendation.*

*7. Yellow box markings – implemented*

*8. Provision of a STOP line and STOP sign – implemented*

*9. Provision of Stop here to close the gates signage – implemented*

*11. Yellow paint at the strike-in point for train drivers – implemented*

*Network Rail investigated the provision of secondary MSL lights but chose not to take this option forward as new larger MSL lights were installed on 23 April 2017. These are higher, brighter and larger than the existing lights to assist tractor and HGV drivers. The new lights were reviewed by the Authorised user on the 3 May 2017 who confirmed they were an improvement.*
