# OLE Hot Weather Resilience Targeted Assurance Review

31 August 2021

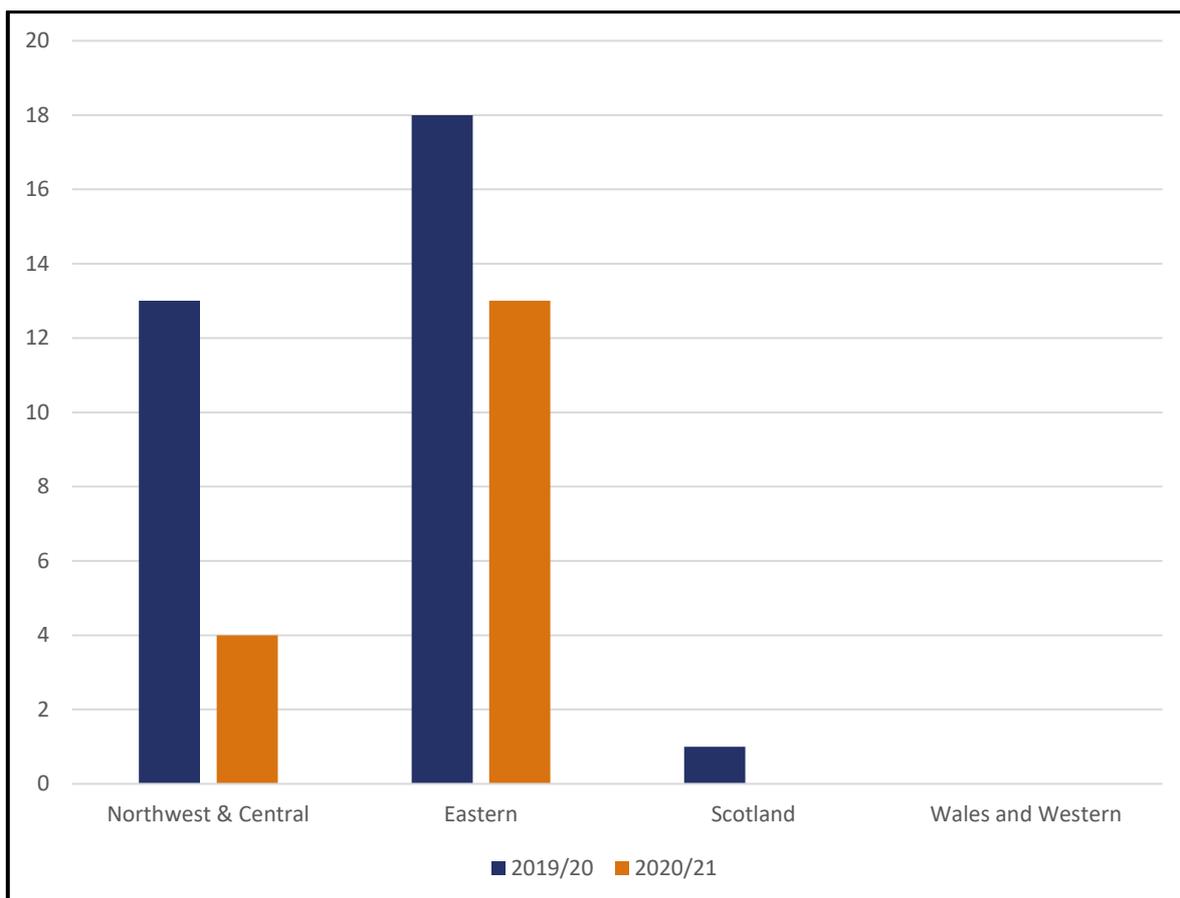
A total of 34 hot weather related OLE incidents were recorded in 2019 in three regions while 17 was recorded in 2020 affecting only two regions. Both Eastern and Northwest & Central (NW&C) regions were mostly affected in 2019 and 2020. In 2019, the incidents culminated in delays of 38,994 minutes and 30,566 minutes in both regions respectively. Figure 3.0 shows the number of hot weather-related incidents per region in 2019 and 2020.

Figure 3.0 – OLE Hot weather-related incidents in summer 2019 and 2020

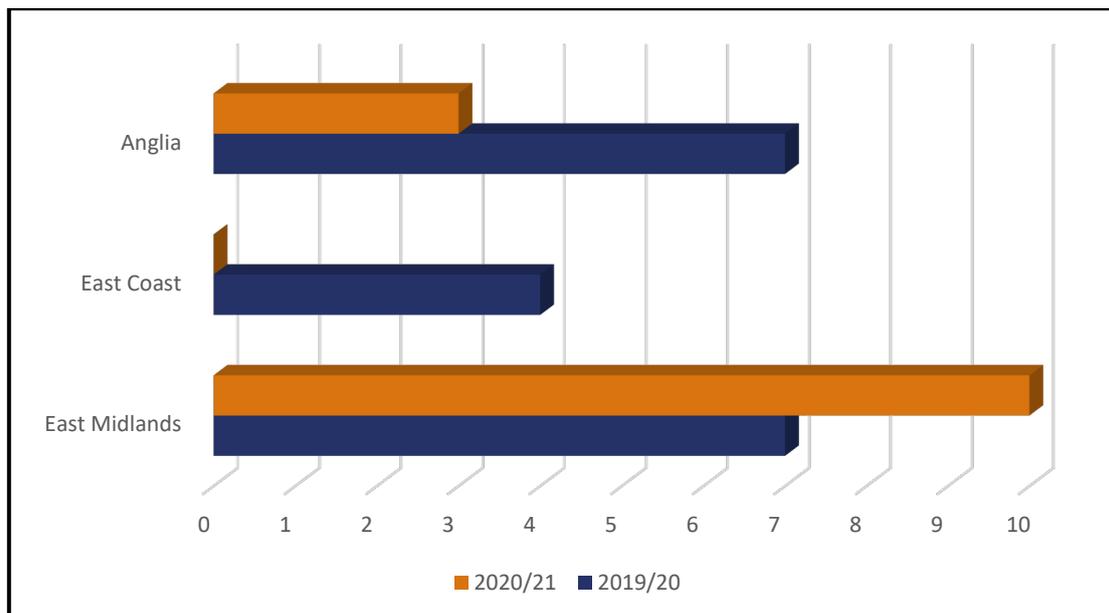
The Eastern region comprises four routes which are Anglia, East Midlands, East Coast and North & East. 26% of the OLE defects in the region are hot weather related. In the North & East route, the OLE performed well in 2019 and 2020 with no heat related incidents recorded. However, the OLE in the other routes experienced some significant heat related problems. Figure 3.5 below shows a comparison of the number of OLE hot weather-related incidents per route in the Eastern region in 2019 and 2020.

*Figure 3.5 – Number of hot weather related incidents in Eastern region (2019 and 2020 excl. North & East route)*

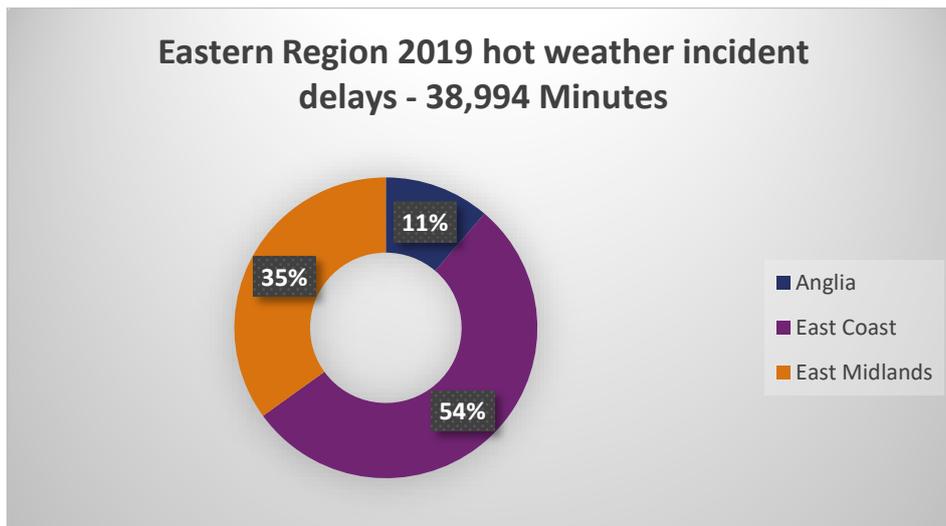
*Figure 3.6 – Percentage contribution to delay minutes per route in Eastern region (excl. North & East route)*

Despite having the lowest number of hot weather-related incidents in 2019, the East Coast route contributed 54% of the delay minutes. This is attributed to the severity of the incidents and the criticality of the route in terms of traffic. In summer 2020, however, the OLE in the route performed well with no record of weather-related incidents. On the other hand, incident report shows that East Midlands route performed worse in summer 2020 than it did in 2019 with more heat-related Balance Weight issues. However, comments from the route suggested that the increase in number may have been due to reporting issues with train drivers rather than actual incidents.
