# Network Rail Track Renewals in Control Period 4

Site Inspection and Review of items proposed for renewal on Primary Routes in 2009/10 to assess the justification for the timing and the proposed engineering specification.

Richard Spoons Associates Ltd

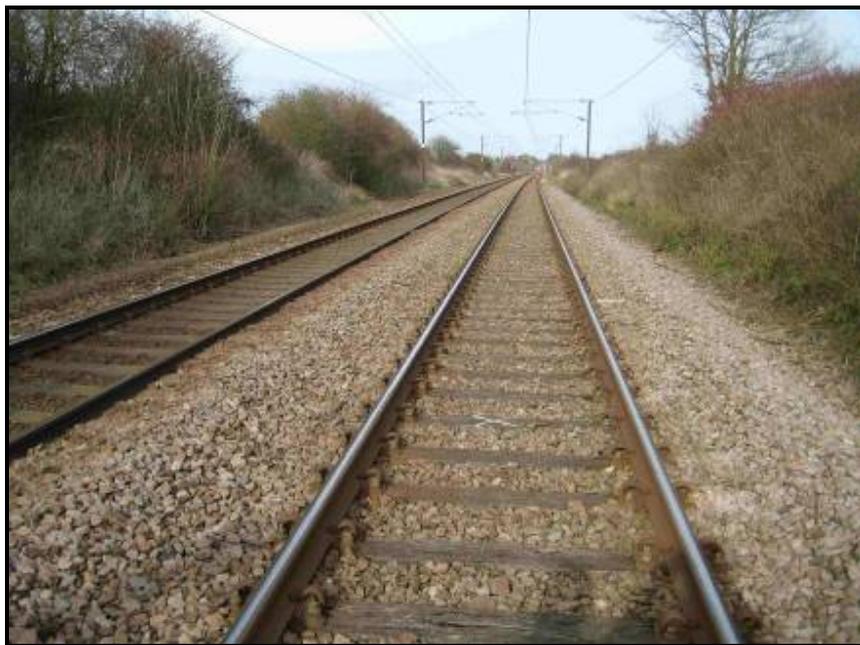
Figure 14. Moulton plain line on the up main approximately 15 miles north of Diss

This is an interesting section of the Norwich to London main line. The annual tonnages are relatively low for a 100 mph main line and the track has been well maintained with good natural drainage. However, the hardwood timbers are now badly decayed in places and the Mills fastenings are working loose. The rail is 110A flat bottom now showing 5mm head wear. The item is 351 yards long and will be renewed with G44 sleepers and NR60 rail in 2009/10. The site specification includes an additional 198 yards of reballasting to the south on a 2006 renewal of sleepers and rails where Balfour Beatty's New Construction Train put the new materials on the old ballast bed.

None. Due to the severe decay evident in the sleepers and the age of rail, deferral should not be considered.

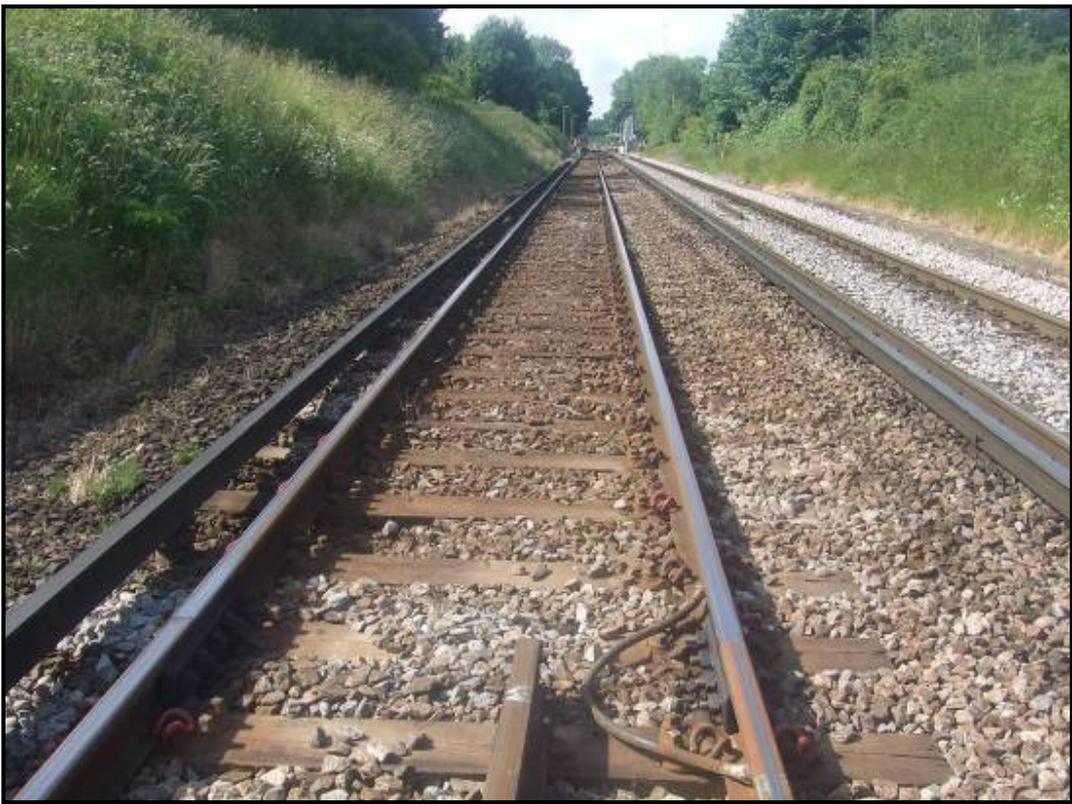
**Figure 15. Milford down line looking south toward Milford station.**

The existing track was installed in 1963 and is jointed with 24 wood sleepers per length; 110A rail and predominately Pan2 baseplates secured with chair screws. The track is in a shallow cutting and lies in a gentle curve at the London end before a straight section as Milford station is approached. There is a short cess drain between 36m 154y and 36m 308y.

The general condition for this 45 year old track was acceptable; however, closer examination showed that several components of the track system were reaching the end of their asset lives. The ballast was dry and consisted of crushed ballast with fines below the sleepers, no longer able to deliver good results from maintenance tamping. Many sleepers showed signs of decay and there was evidence of indentation at the baseplate seat. New chair screws had been installed under maintenance in 2003. The rail joints were visibly dipped. Records showed four locations where rail end dip angles had required remedial attention in the last 18 months. There had been 12 rail defects removed in the last 10 years. Track geometry recorded data confirmed the observed good line and level together with the dipped joints. At the Milford station end a crossover had been removed in the last two years and replaced with plain line. This renewal will include rerailing through this site to remove several joints and an old breather switch.

None based on the age of the rails and the general condition of the rail joints and sleepers.

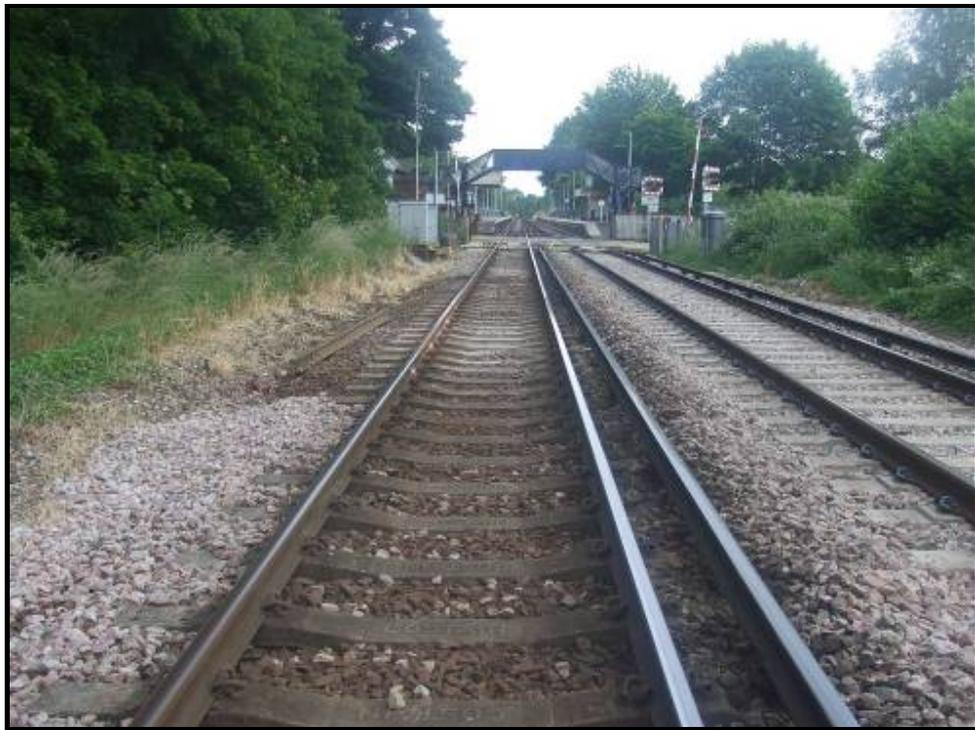
**Figure 16. Up line approaching Milford level crossing and station**

The problem statement identifies the principle driver for this renewal is the ballast condition. The track was installed in 1964 and is cwr on F24 concrete sleepers with pandrol fastenings at the north end and through the platform from 36m 214y to 36m 545y. From 36m 545y to 36m 1320y at the south end it is jointed track with spiked baseplates and Heyback fastenings on wood sleepers. There was no evidence of concrete sleeper deterioration; however, the wood sleepers are showing signs of decay. The rail is 110A. The cwr is in good condition; however the jointed section has had 9 dip angle exceedences and 5 rail defects removed in the last 18 months. Recently the level crossing surface has been renewed around the old cwr track and to the north of the station a turnout which formed a crossover to the down line has been removed and replaced with plain line. Through the station there is a six foot drain. Ballast conditions are very poor immediately south of the station and at two locations south of the station the ballast has broken down leading to the classic "wet bed" (see picture above). In the jointed track the ballast is crushed and dirty. The track geometry is now maintained by stoneblower. Consideration should be given to providing a drain in the up cess from the level crossing south for 200 yards. Alternatively the shoulder ballast should be removed completely to a level that coincides with the 1:30 crossfall at the ballast/formation interface to allow water to drain away.

None due to the condition of the jointed track and the ballast condition leading up to the station from the south. It is recommended that attention be given to retaining and using the six foot drainage through the station, ensuring an optimum alignment through the level crossing and providing water drainage from the track south of the station.

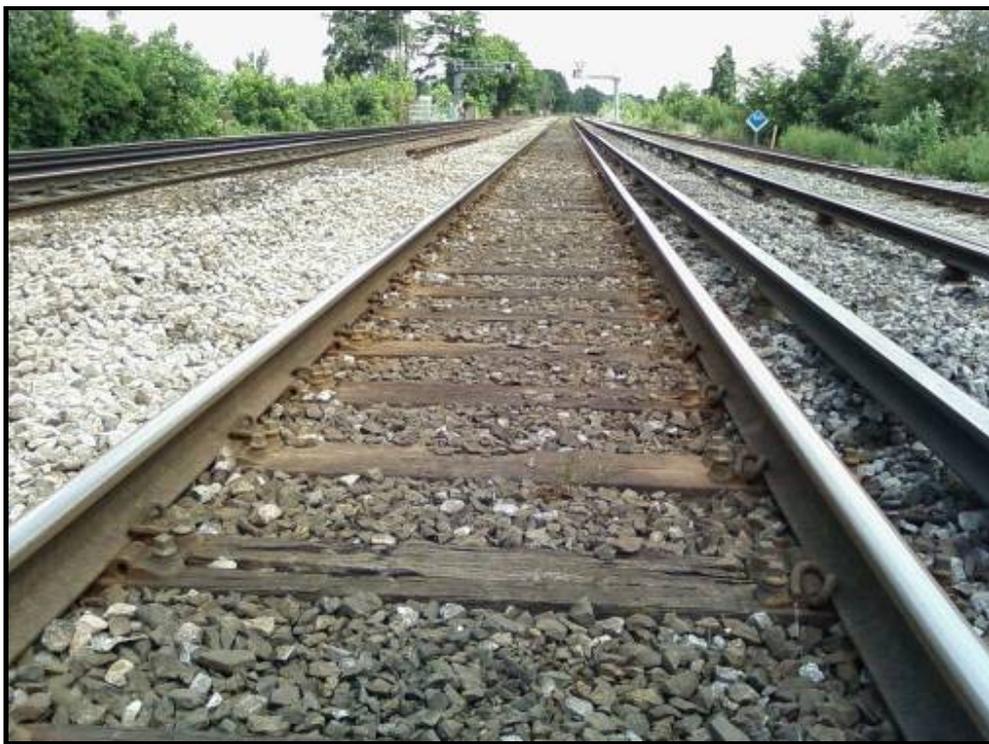
The proposal is to renew 575 yards on the down fast between Basingstoke station and Worting Junction in 2009/10. There are four tracks leading up to Worting Junction. The down fast and down slow are separated from the up fast and up slow by a tenfoot. The route speed is 100 mph although the linespeed at this location is 90mph. The site proposed for renewal commences at 49m 1412y and abuts the London end of Worting Junction at 50m 229y. The earliest material indicates an original installation year of 1963. The 110A rail sits on Pan 11 baseplates secured to wood sleepers. EGMTPA have increased since the BR class 442 multiple units which operated the services to Bournemouth have been replaced by heavier class 444/450 units. There is evidence of the track system coming to the end of its economic life with gall in the rail foot over the baseplates and several baseplates spikes are loose with corresponding indentation on the sleepers. Sleeper condition is poor with evidence of decay on the surface. Ballast is crushed and dirty with fines, resulting in stoneblower being the only effective geometry maintenance tool. The track alignment is on a gentle curve leaving Basingstoke station then running straight up to Worting Junction, which, together with a naturally draining formation and shared route tonnage with the slow line, is the reason this site has lasted for 45 years. Geometry traces

recorded in May 2008 show good alignment but less than good twist and top traces with some general gauge widening. EGMTPA is 11.0.

Figure 17. Basingstoke down fast looking toward London.

None, due to the general condition of the track system.

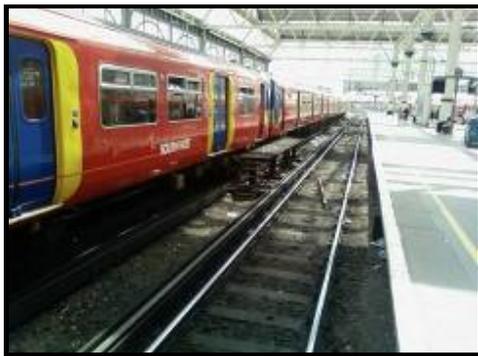
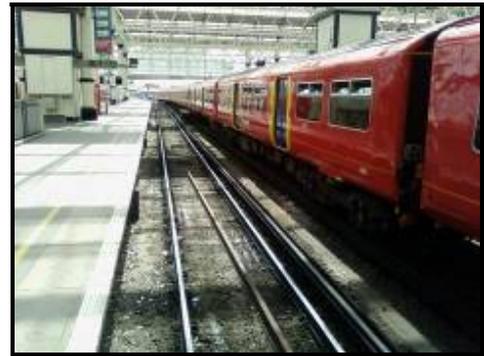
These two proposals are to renew the jointed tracks in platforms 3 and 4 at Waterloo Station in 2011/12. In both cases the drivers for renewal are dirt and contamination from continual use by trains since the tracks were installed in the late 1960s.

Figures 19 and 19. Waterloo Station platforms 3 (left) and 4 (right)

Network Rail has plans to improve capacity at Waterloo station during CP4. This may entail closing platforms 1 and 2, thereby creating room to lengthen platforms 3 and 4. This would be the ideal opportunity to renew the tracks in these platforms and create a reduced maintenance track system, possibly with slab track.

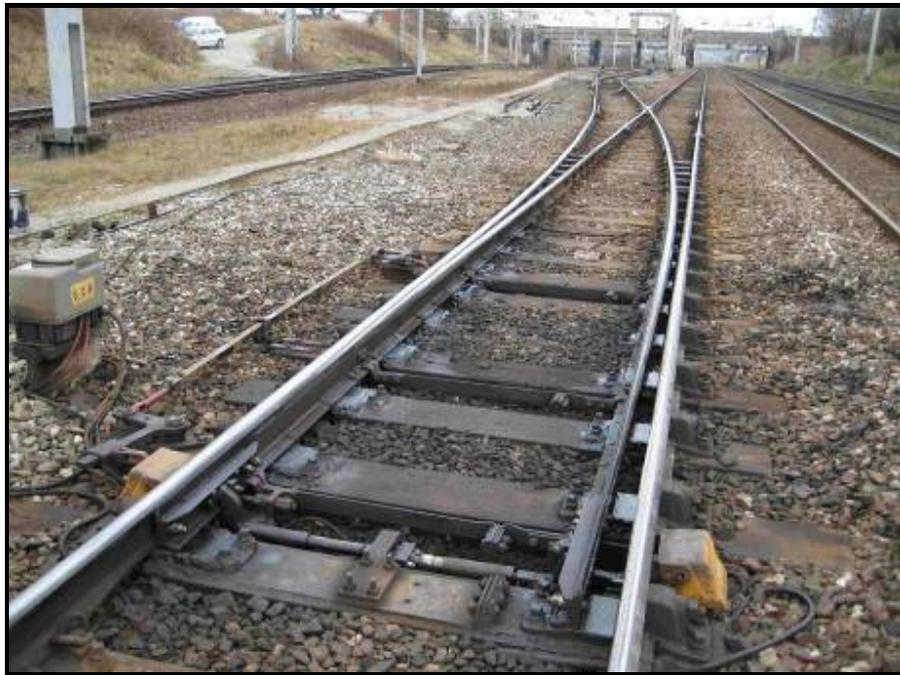
Figure 20. Basford hall junction 52B points looking north.

The layout was installed in 1971 and is made up of 113A vertical rail on hardwood timber bearers. The switches to 52B points were renewed in 1998 (LHS) and 2001 (RHS). The crossing was renewed in 2003. Both sets of switches were renewed at the trap points; LHS in 1987 and RHS in 2005. The ballast conditions are poor with no effective drainage system. The timbers are showing signs of delamination and several have been changed. This is a slow speed high tonnage connection.

The proposal can be deferred from 2011/12 from a review of engineering criteria without risk of component failure or derailment, providing the current levels of maintenance care is continued. The track layout at Crewe was completely renewed, north and south of the station, in a major 49 day

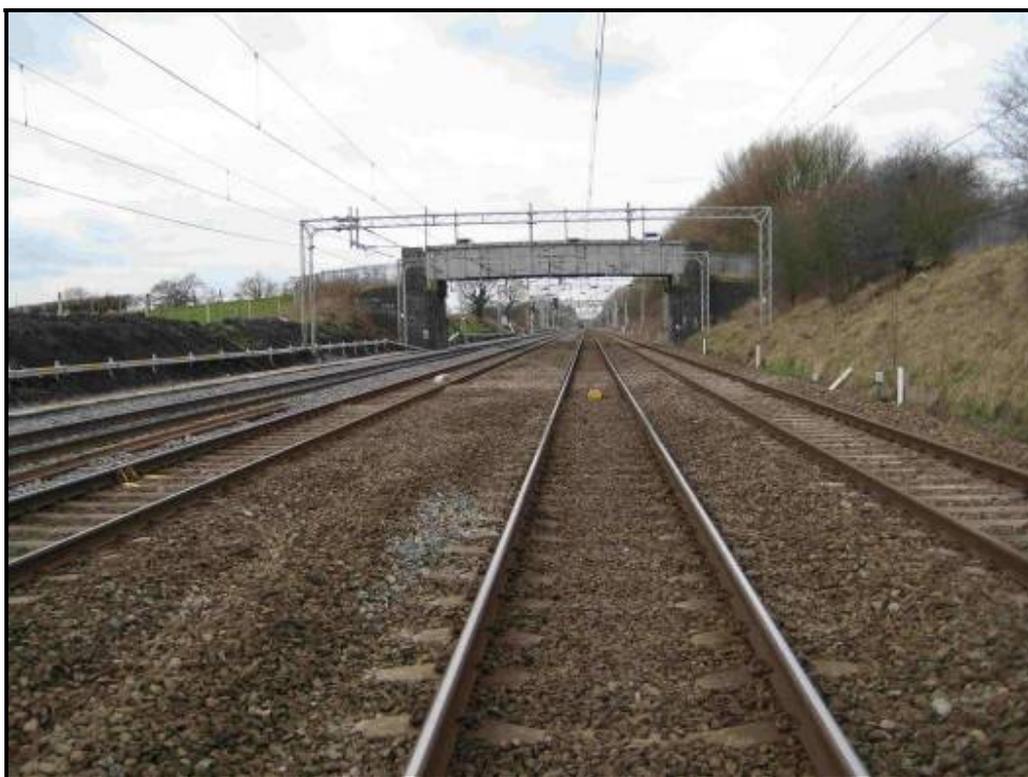
Figure 21. Hartford Up Fast looking north

As can be seen from the photograph, the track is straight concrete sleepered cwr with Pandrol fastenings. The rail is 1982 113A FB and the F23 sleepers 1969. This item was most probably relayed in 1969 and rerailed in preparation for the introduction of the Advanced Passenger Train in 1983/4. Records show it was reballasted by ballast cleaner in 1989. The track geometry is good except for one eighth of a mile under the overbridge where SDs of 2.57 for 35 metre top and 5.0 for 70 metre alignment were noted.

The item was being inspected for the 2011/12 workbank. The 1982 rail should still have some serviceable life by then, however the sleepers will be beyond their expected life and the ballast is already showing signs that it can no longer meet its purpose. Deferral beyond 2012 is not, therefore, recommended.

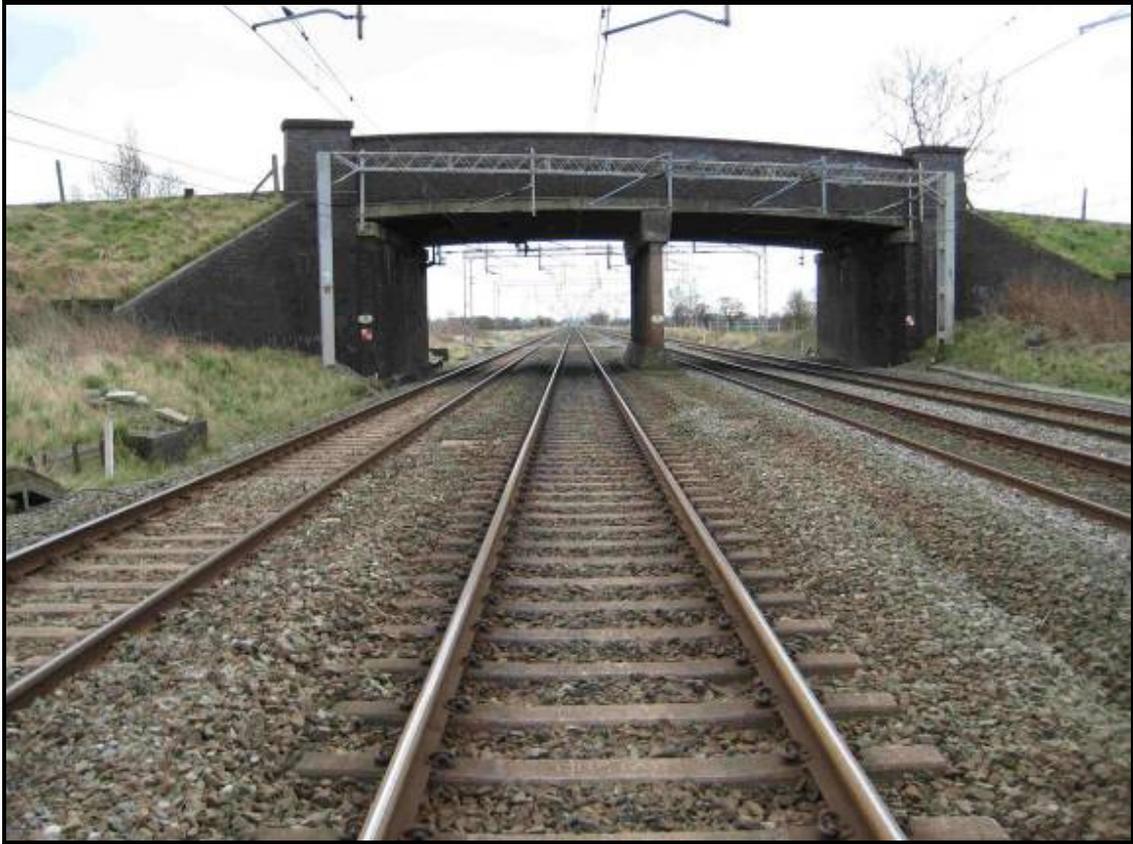
Figure 22. Minshull Vernon up fast looking south

The item is on a straight alignment with a ten foot space to the down fast and a six foot to the up slow. The Network Rail records showed the age of rail as 1978. However, site inspection found only 1985 113A rail on F27BS concrete sleepers with Pandrol e1809 clips and 7.5 mm pads.

Consideration for renewal in late CP5 or early CP6 is recommended due to age and condition.

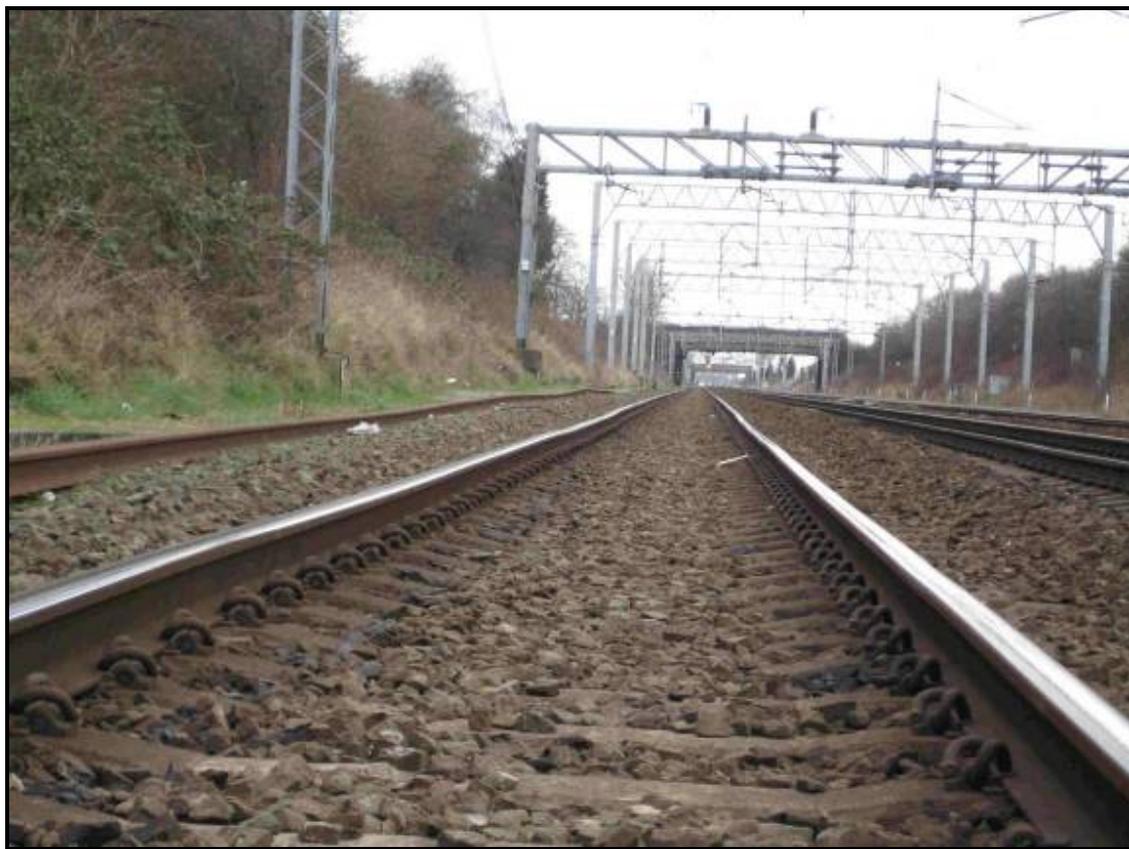
**Figure 23. Crewe Coal Yard North Down Slow renewal site**

The track was last renewed in 1981 with 113A rail on F27 concrete sleepers. The engineering components appear in good condition. The problem is the formation and drainage which are producing poor track quality at two distinct locations through the site. As the inspection party walked from north to south, the first poor piece of geometry was in the eighth of a mile between 159m 1100 yards and 159m 880 yards. The poor top can be seen in the foreshortened picture above. Quality then improved until the last eighth of a mile was reached between 159m 220 yards and the 159 mp. The 35metre and 70 metre top was in the poor category. Matters were not helped by underbridge No. 3 with most likely a shallow depth of ballast on the through deck.

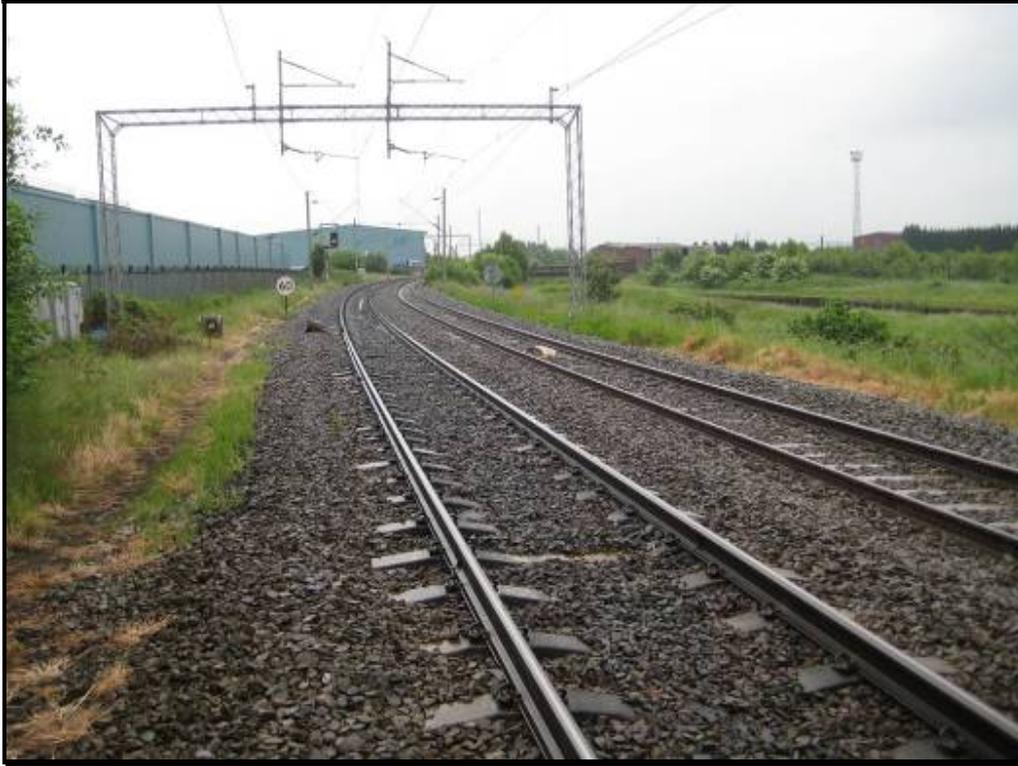
The track was installed in 1969 with F23 sleepers. At the southern end there is a short length of new G44 sleepers installed in 2002, however the rail and ballast were not renewed. There is still some 1969 rail on the low leg, however, the high rail is either 1993 (low mileage end) or 2001 (high mileage end) due to the heavy sidewear, despite evidence of working lubricators. Ballast is dirty with fines, but no evidence of slurry. Track geometry is generally good, with some minor long wave misalignment approaching an underbridge. As a consequence of rerailing for sidewear with 60ft rails there are many thermit welds on the high rail.

Figure 26. Albion. Up Fast looking south. The 60 PSR sign is at 6m 440y.

Total renewal at this location should be before the two sites at Wolverhampton North due to the sharper radius and stress on the fastenings under the high rail. However, as with two Wolverhampton North sites, a detailed investigation should be conducted into the design of the track geometry. Is it optimum for the speed and traffic to maximize life of the high rail? Consideration should also be given to using a head hardened steel in the high rail when it is renewed and a maintenance policy of transposing rails at a defined level of sidewear in the future.

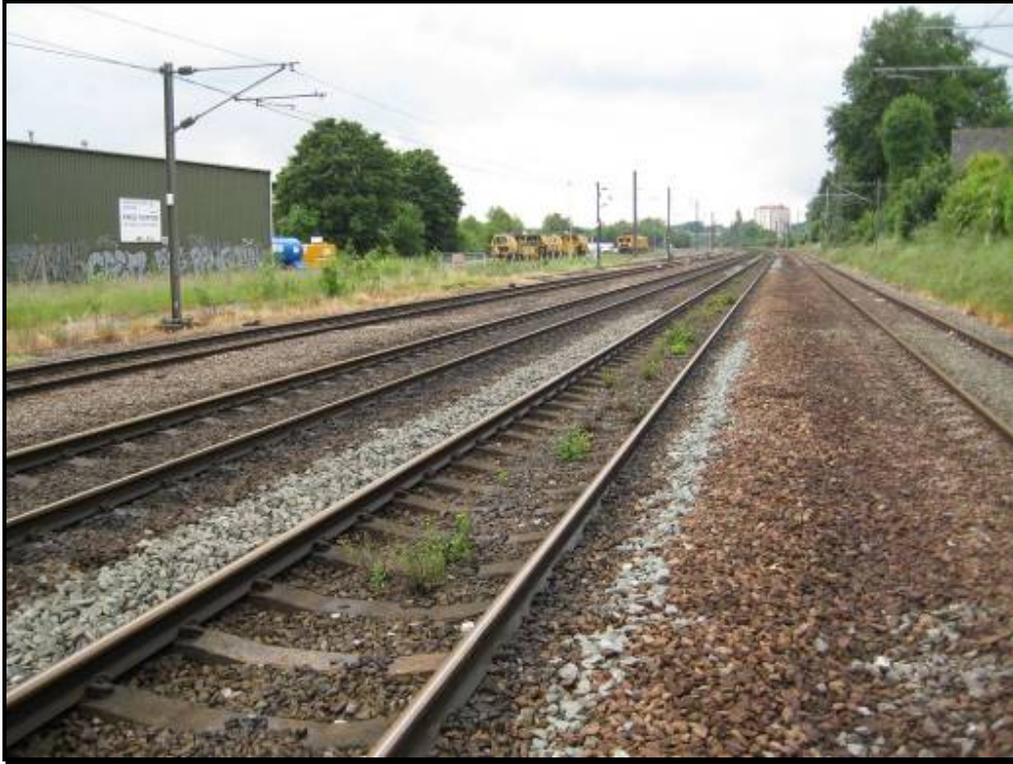
Figure 27. Kings Norton Up Main looking towards the high mileage (south west)

The track was installed in 1969 with early F27 sleepers. Geometry is straight in the low mileage with a gentle curve to the high mileage. Quality has been held with recent use of a stoneblower. The sleepers are starting to show fine stress cracks and there is a record of over 40 minor rail defects being removed over the last 10 years. The ballast is very poor and water is unable to drain naturally from the ballast/formation interface. Consideration should be given to the design and installation of a drain to the six foot between the up and down main lines.

None. This item could deteriorate very quickly in the event of a long period of heavy rain.

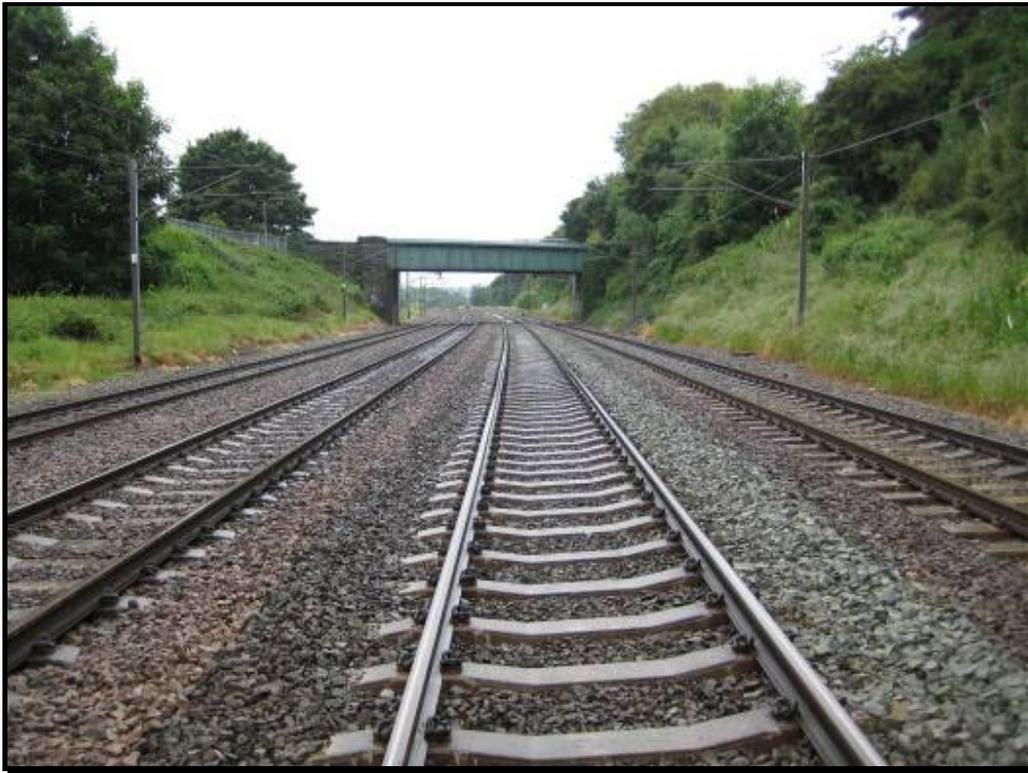
This item is on the same route as Kings Norton above. It is on the up main line and the mileage is from 47m 1220y to 49m 350y. Line speed is 90 mph and the renewal proposed for 2009/10 is the complete section of plain line between Kings Norton Junction and Halesowen Junction. The track was installed in 1969 with F27 early sleepers and 110A rail. It is now maintained by stoneblower due to the poor ballast conditions. The poorest track geometry observed was under the overbridge at 47m 1530y which shows poor and very poor consecutive eighths for 35m top on the NMT outputs. There is some very slight sidewear on the high rail, but this is not the principle driver of the renewal, which is the general poor condition of the track

system and the high number of minor rail defects (approximately 80) removed in the last 10 years.

**Figure 28. Northfield Up Main looking towards Longbridge**

None. This item should be renewed after the item at Kings Norton as the ballast conditions at Northfield are not quite as poor.

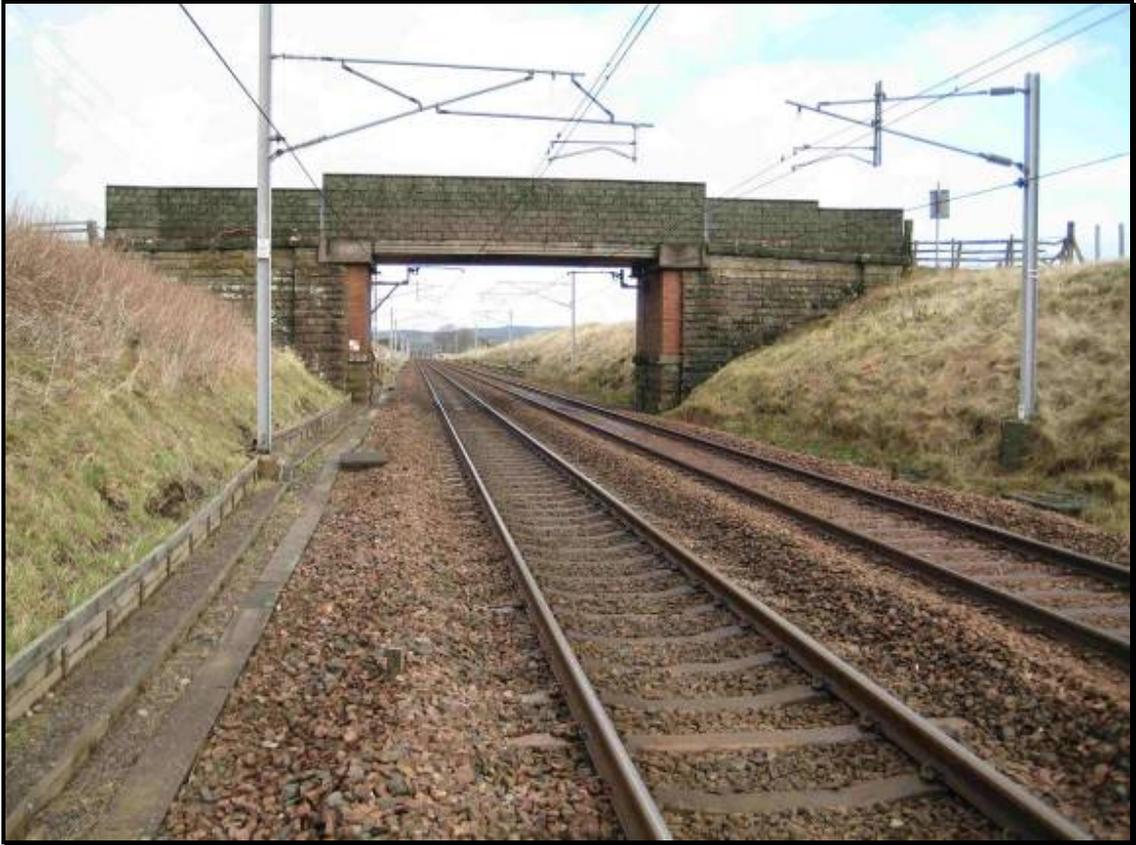
Figure 29. Symington renewal site looking north. Overbridge 359 at 65 miles 59 ch.

The existing track was installed in 1967. It has F23 concrete sleepers; however the rail was renewed in 1987. The geometry is in the good band except for the northern end of the site where it runs into the switches and crossings at the Emergency Ground Frame.

Although the track was in good geometric condition on the day of inspection, it is maintained by stoneblower as the prevailing ballast conditions are poor. The cess drainage did not appear blocked.

Several of the F23 sleepers were cracked and approximately one in eight had been changed. The annual tonnage is 14 EMGTPA.

A trackbed investigation report has been produced for the renewal and it confirms the poorer ballast conditions north of overbridge 359.

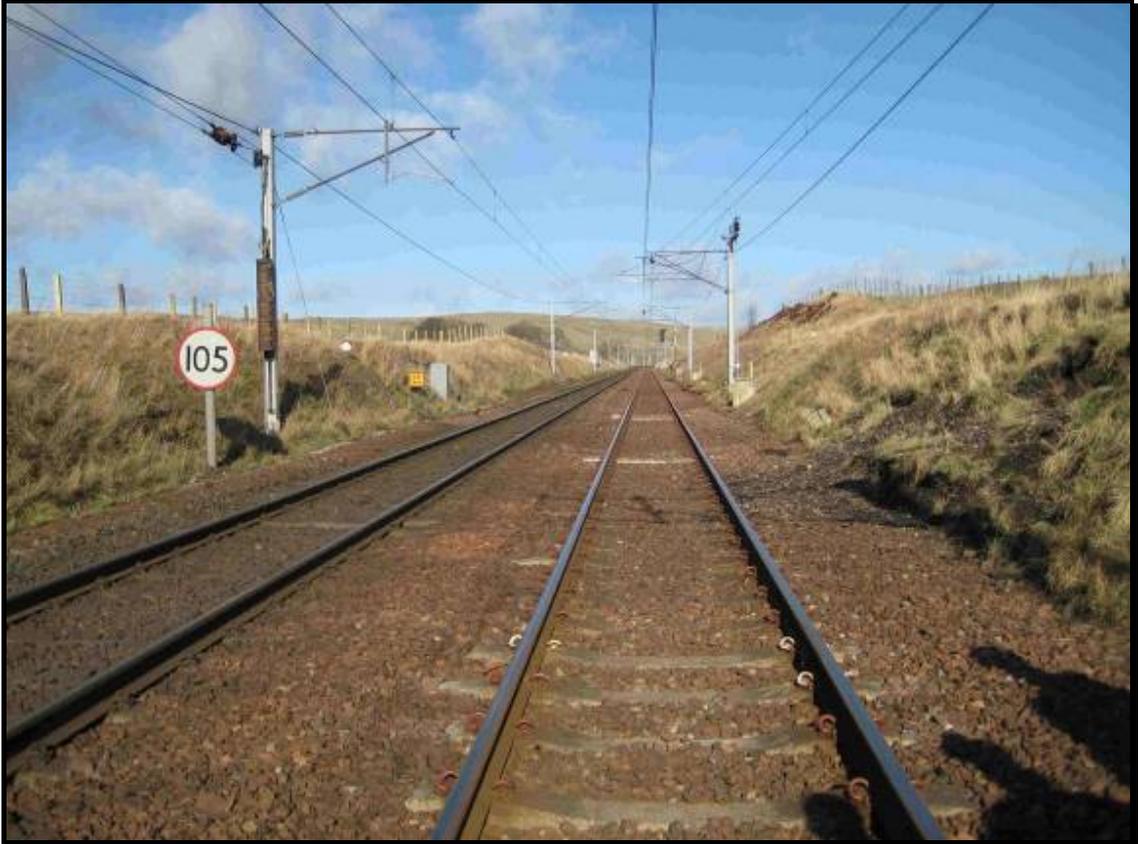
**Figure 30. Abington, looking north**

The existing track was installed in 1965 and rerailed in 1987. Pads and fastenings have been renewed in the last year. The ballast conditions are poor, with many voided sleepers caused by the rails having 'rail memory'. Rail memory is a track phenomenon whereby over time on heavily trafficked routes, the track tends to form a horizontal longitudinal profile to mirror the stiffness of the sub-base. Once this happens the rail head develops a longitudinal profile similar to long wave corrugation. This in turn creates loading and unloading of successive sleepers, particularly if they have a spacing of 24 per 60 feet, the original BR specification for cwr in the 1960s. Evidence of this problem can usually be found where ballast at the sleeper ends vibrates as the sleeper is successively loaded and unloaded and sharp angled stones turn to pebbles, leaving a white dust deposit in the process. Over time the track geometry quality reduces and the long term correct

Ballast condition and sleeper age are put forward as the drivers for renewal in the Problem Statement. This is correct, as the sleepers are now over 40 years old and several are cracked and have been changed. Evidence they are near the end of their economic lives. The rail, however, still has 10 years of serviceable life and Network rail should ensure that it is cascaded to a secondary renewal where the specification is suitable.

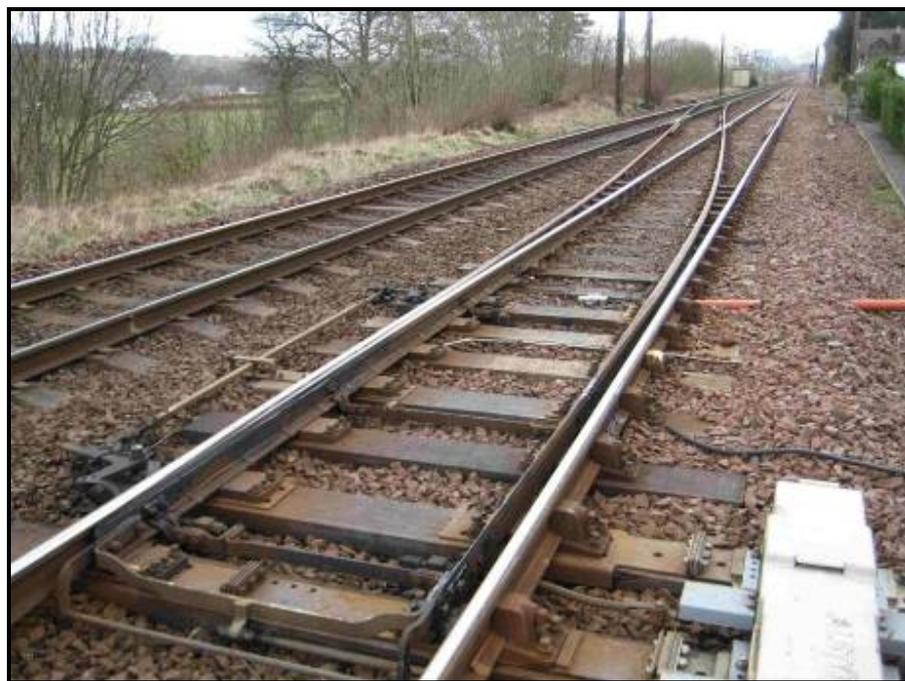
**Figure 31. 2B and 2A points looking north.**

The junction was last renewed in 1970. It is sighted on straight track and is used in emergencies and for engineering work. All the switches and crossings have been renewed in the last eight years, except the trailing switches to 2A points in the down main. Two small isolated instances of RCF were noted. One is on the up cess rail in the check rail area and the other is

The renewal specification is for a like for like renewal with modern equivalent materials. Network Rail's modelled renewal year for this site in their Business Plan would be 33 years or 2003. However, the overall good condition of this junction at Wamphray, and the fact that so much ironwork has been replaced in the last 8 years, suggests that 2009/10 is a little premature.

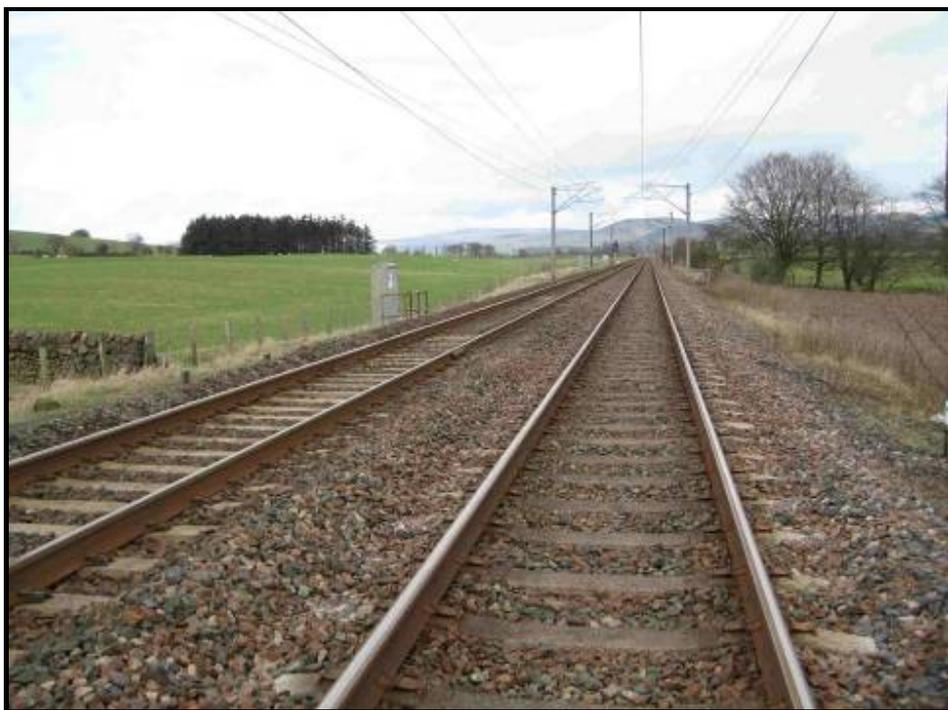
**Figure 32. Dalmakethar up line looking north**

The track is early CWR with F19 concrete sleepers and SHC fastenings laid at 700 mm centres (26 per 60 foot) in 1967. The track is straight and the recent records of track quality show all parameters in the good band. Rail age is 1967. The track is on a slight embankment giving good drainage to the cess. This is a stretch of railway appearing to give no undue problems to the

Yes. This proposal could be deferred to CP5 based on the condition observed during the inspection. For track of the same age, that which lies in a straight line will generally have a longer service life than that on curves. Good natural drainage also helps promote a longer service life. This site has both.

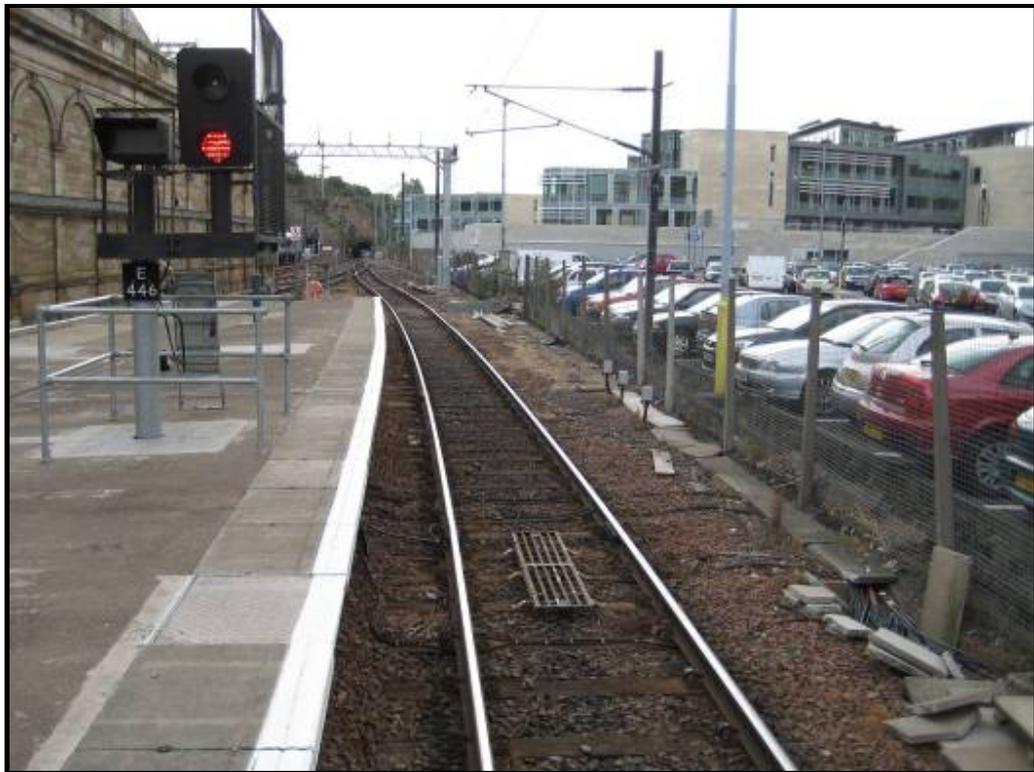
**Figure 33. Platform 8 (Down Suburban) looking south**

The existing track dates back to 1957 with wood sleepers and mills clips to the east and elastic spikes to the west. Spot maintenance replacements have been made with newer rail and pandrol fastenings. Drainage is ineffective, especially at the ends of the platform. At the west end original drainage seems to have been blocked by recent track renewals and is under investigation. Oil spillage and general detritus is prevalent in the four foot. There are over 20 locations where signal cables cross the track. Maintenance is difficult, and is largely lifting and packing joints, tightening bolts and dealing with water during heavy rainstorms. The area looks very untidy and is not becoming of a modern station in a capital city. Track geometry is not a major issue due to the low speeds. The current specification is for G44 sleepers. Consideration should be given to shallow depth sleepers to reduce track construction depth.

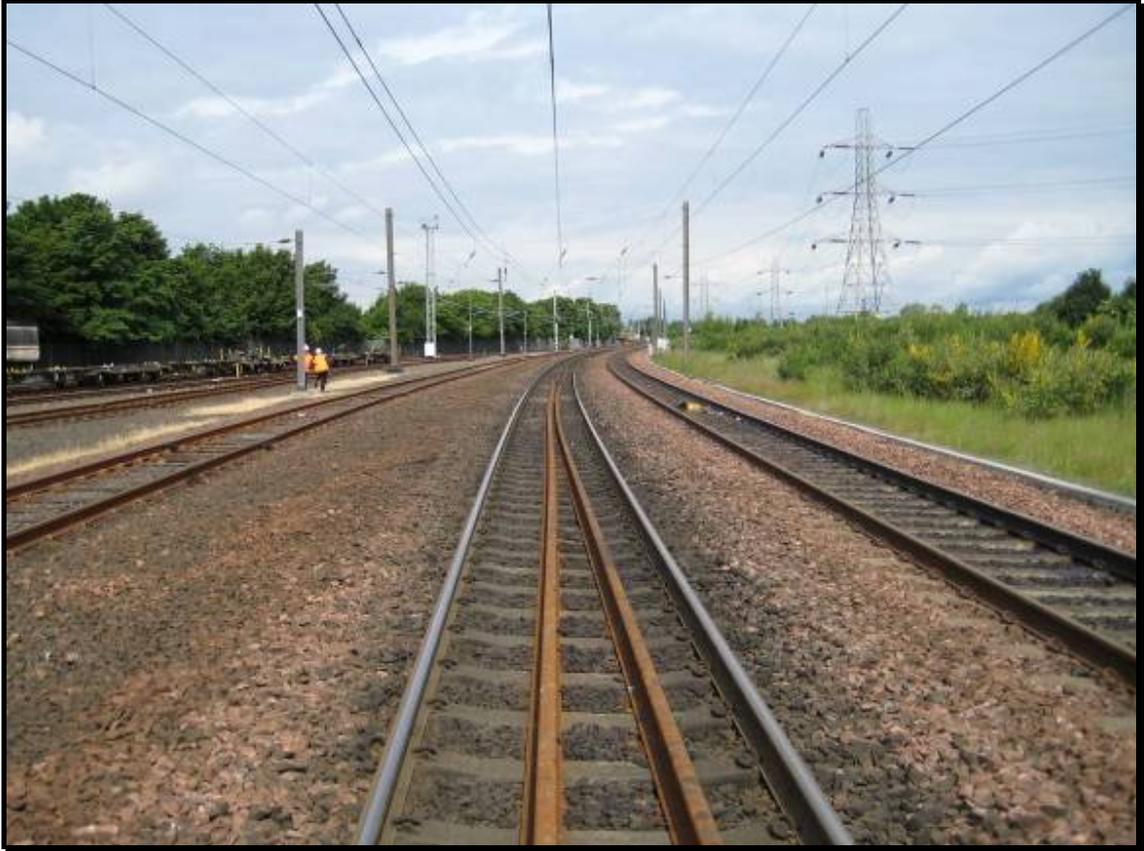
Figure 34. Portobello looking north

The existing track was installed in 1971. At the low mileage end there are some early concrete sleepers with Pan 9 baseplates. These are showing signs of working loose. The remainder is F27 which have been repadded with 7.5 mm pads. The item was originally proposed for renewal in 2007/08 and the new NR60 rails unloaded in preparation. It has now been placed in the 2009/10 programme. The high rail was renewed in 2002 due to RCF. There are isolated top defects visible to the eye which may be due to a need for machine maintenance, especially between 3mp and 3¼mp. The general alignment is good, including through the reverse curve at the low mileage end. Ballast conditions appear good too. This site is considered ideal for ballast cleaning.

The driver for renewal in 2009/10 is the poor condition of the pan 9 baseplated section. The high mileage end has poor geometry and inclusion as one item is justified on the basis of construction efficiency. It would be beneficial if the 2002 rail could be recovered for re-use.

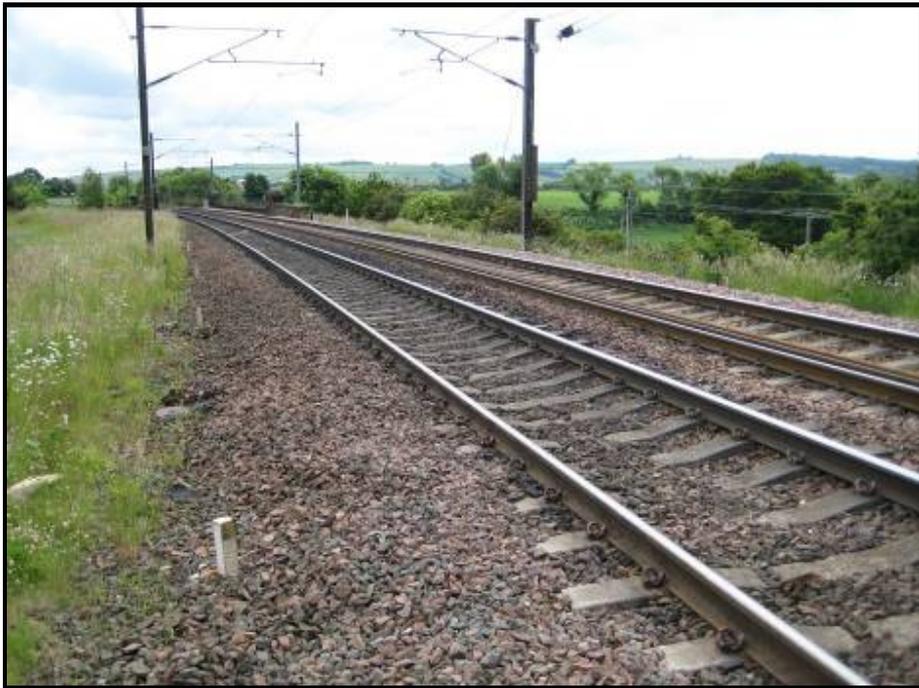
and 6m 590y. East of 6m 590y the line speed returns to 125 mph. EMGTPA is 24.5. The eastern end of the site abuts a recent renewal with Cen 60 rail and G44 sleepers. It would appear that when this renewal was undertaken a few years ago, the specification included a geotextile and possibly new drainage to link into the existing. It would now appear to have been an inadequate formation protection layer, as the top through overbridge 29 is very poor.

From the site inspection in June 2008, the recommended specification and extent of the high mileage end of this site is not the correct engineering solution. There is a need for a full and detailed soils investigation of the track bed from 6m 660y to 6m 1100y to be undertaken. Between these limits the report has identified soft homogenous fine soils one metre below rail level with a bearing pressure value lower than 40Kn/m<sup>2</sup>. This further work is likely to result in both a design for a more robust formation protection layer than a geotextile, and associated renewal of the existing cess drainage system, which was observed to have standing water during the visit in June 2008. Furthermore, the extent of the formation work will now extend the site into the new G44 Cen 60 track and through the overbridge.

Figure 36. Monktonhall looking east, between 6MP and 6¼MP with underbridge 28 in the distance

The recommendation for this proposal is 1) urgently undertake an soils investigation through the old station and overbridge 29 to define the type and extent of formation treatment necessary; 2) carry out this work and the track renewal from 6m 575y to 6m 845y in 2009/10; 3) renew from 6mp to 6m 575y later in CP4.

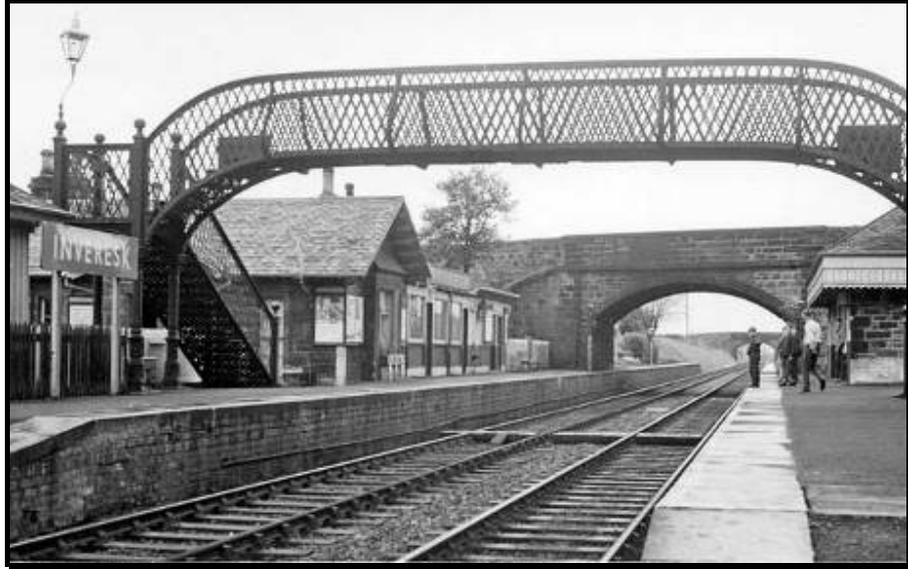
Figure 37. Inveresk station in 1964. The picture was taken from the down side at a point opposite that for figure 36 above. © J L Stevenson

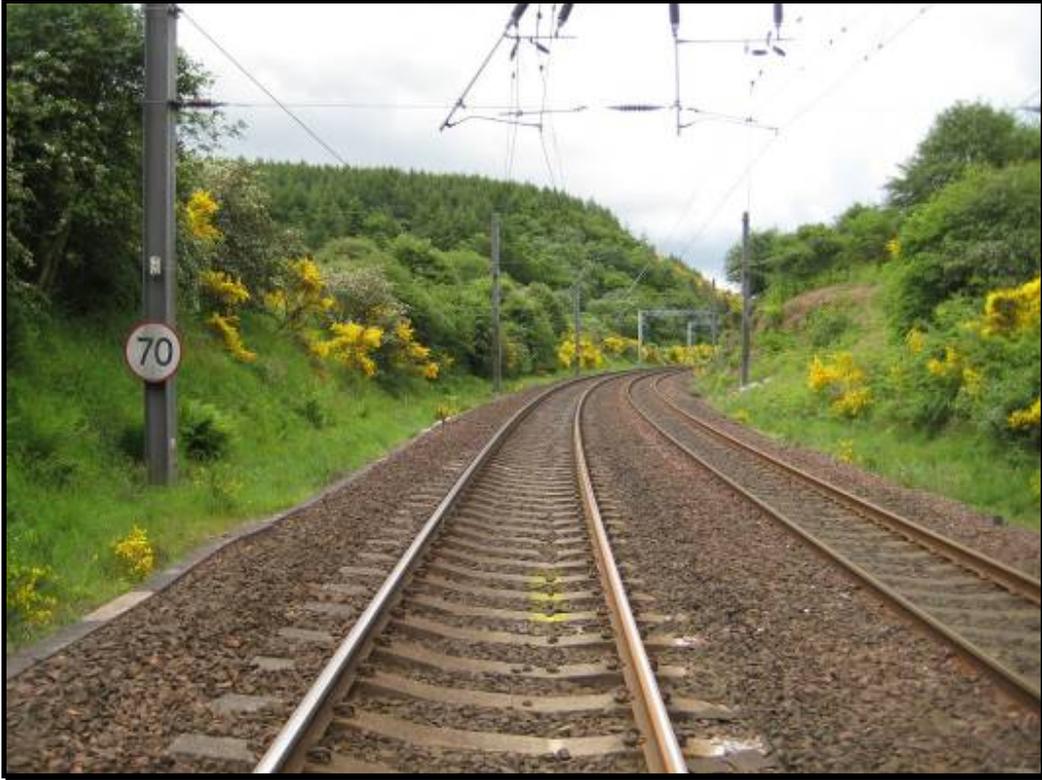
This is a rerailling proposal for the up East Coast Main Line over 1028 yards from 39m 136y to 39m 1164y. Between Innerwick (34½mp and Berwick upon Tweed (67mp) the East Coast Main Line geography presents gradients and curved alignment such that the maximum line speed varies between 70mph and 90mph. One of the sharpest curves was constructed in 1979 to take the line round the collapsed Penmanshiel tunnel. Here the maximum speed is 70 mph with a series of reverse curves and a maximum track superelevation of 150mm. The present rails were installed in 2002 on F27 sleepers laid in 1975. Up to 25mm surface RCF was also observed on the high rail, despite evidence of rail grinding. Notwithstanding good rail lubrication, sidewear on the high rails has to be measured regularly in order for the maintenance engineers to predict a date and time for rerailling. The evidence from readings taken since the rail was installed new, together with the inspection, confirmed that even with this well maintained track, rerailling of both high and low rails would be necessary in 2009/10.

Figure 38. Penmanshiel up line looking north from 39½ MP. The old tunnel is in the centre of the picture with the 'new' alignment sweeping to the right.

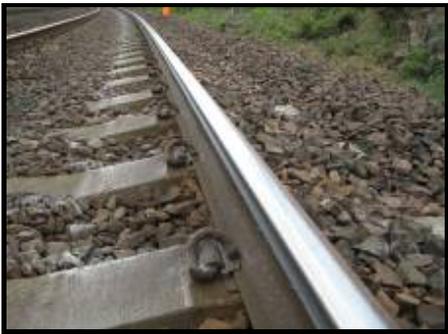
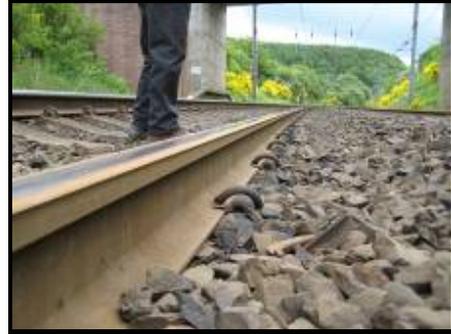
Figures 39 and 40.

The picture on the left (Figure 39) shows sidewear on the high rail and evidence that the foot is pushing outwards, whilst that on the right (Figure 40) shows lipping on the low rail and pressure of the rail foot against the nylon insulators. These site conditions suggest that the superelevation of the track may be optimum for both passenger trains travelling at the maximum permissible speed and freight trains running at a speed which causes proportionally higher vertical forces on the low rail.
