# Network Rail Track Renewals in Control Period 4

Site Inspection and Review of items proposed for renewal on Primary Routes in 2009/10 to assess the justification for the timing and the proposed engineering specification.

Richard Spoons Associates Ltd

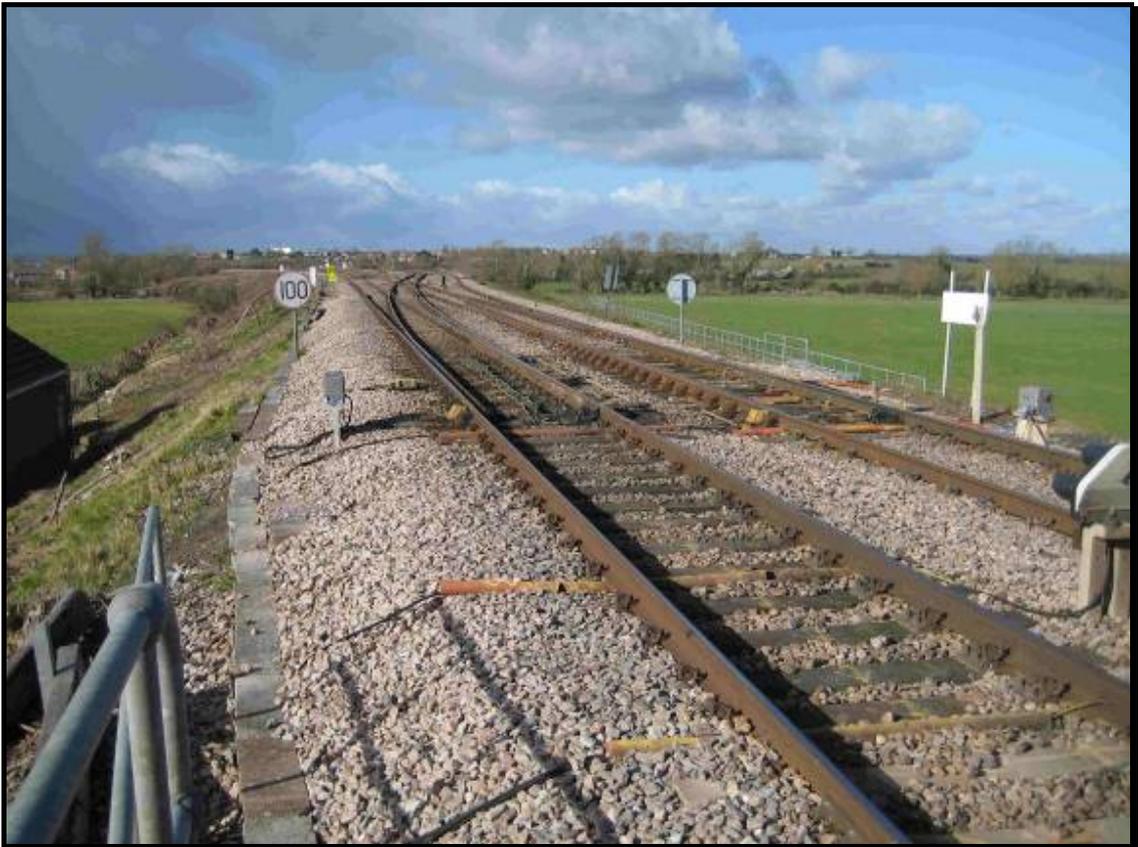
Figure 40. Heyward Road Junction looking towards Westbury from the down side.

There are two Temporary Speed Restrictions (TSRs) in force. On the up main the 30/80 TSR applies for the first 5 chains of the 110 PSR as trains traverse the trailing connection of the double junction and the facing connection of the crossover. The reason for the TSR is track geometry. On the down line the 30/80 TSR is in the direction of Taunton which has a line speed of 100 mph. Again, the reason for the TSR is track geometry, although in this case it is not due to condition but design. The down main line to Taunton (known as the Westbury Avoiding line) was originally approved by

the BR civil engineer of the day for 100 mph line speed. An analysis by Network Rail has shown that the maximum permissible speed through the junction in the normal direction should not exceed 80 mph. The general track geometry is not helped by the recently renewed underbridge that carries the railway over the Heyward Road. The track over the bridge deck appears to be high in comparison to the junction to the west and the crossover to the east. There are 16 units of either switches or crossings in the layout. 9 have been changed between 1991 and 2004. The general condition of the hardwood timbers is satisfactory. Several have been replaced. The layout sits on an embankment giving good natural drainage to the ballast. The toe of the up side embankment has been strengthened by the construction of a retaining wall. Similar work is planned for the down side. Lateral restraining plates have been fitted to all switch timbers.

Based on the inspected condition, and with the maximum speed through the junction restricted to 80 mph, renewal in 2009/10 does not appear essential from an engineering perspective. The renewal specification states that the renewal design for trains using the Westbury Avoiders cannot exceed 80 mph and that a Network Change will need to be approved to change the TSR on the down side to a PSR for passenger traffic. This process will take some time to complete and may require Network Rail to do more work to demonstrate that 100 mph is not economically possible within the constraints of the site. From a railway business perspective an early resolution of the PSR question will give clarity over the renewal dates, which will inevitably be driven by track access to do the work.

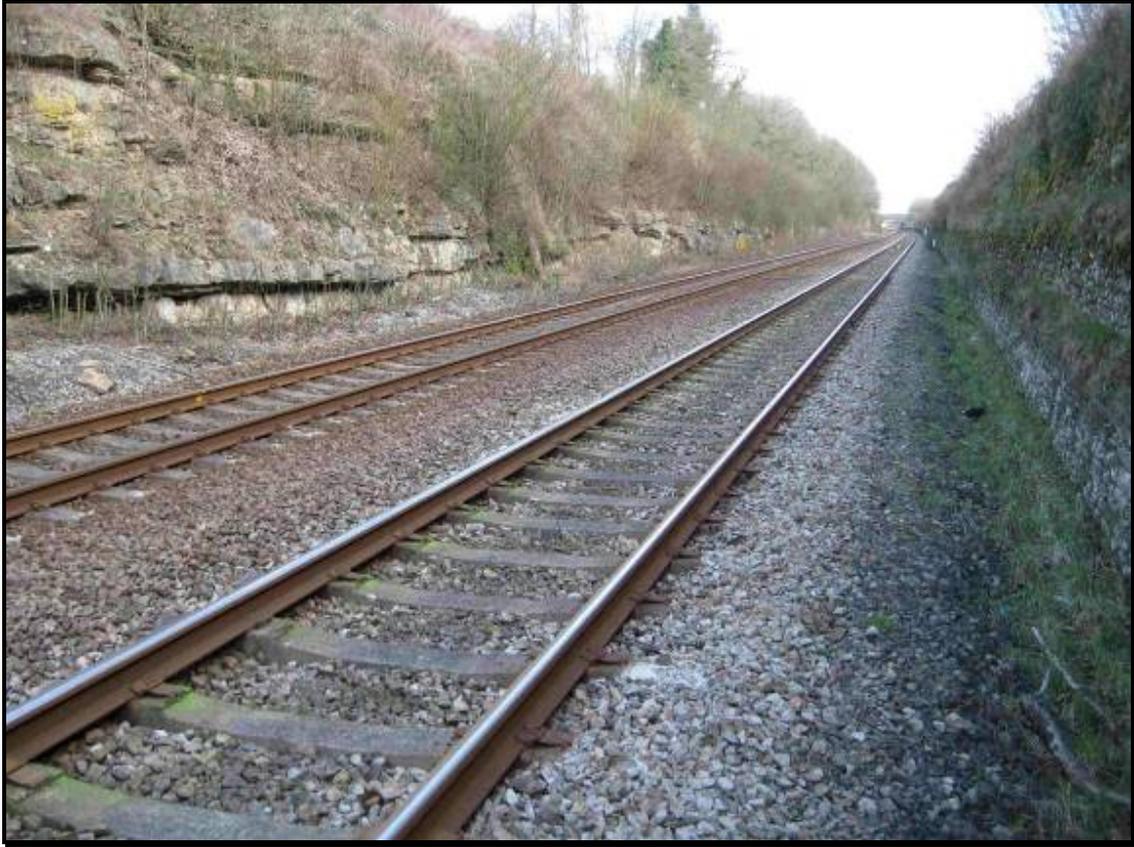
**Figure 41. Corsham. Down line looking towards London**

The item is on a straight alignment in a cutting leading up to the east portal of Box Tunnel. Installed in 1966 this early cwr item has F19 sleepers and SHC fastenings. There is a history of rail defects. The ballast is dirty; however, the observed track geometry is good. Water can drain naturally to the cess and there is a drain in the six foot.

None. Deferral is not recommended due to the potential weakness in the already dipped SmW welds in 1966 rail which could lead to rail failures. SmW is the trade name of a welding process used by BR from the 1950s. The process relied on the judgment of the welding team to ensure the correct pre heat had been given to the rail ends before the molten Thermit portion was dropped into the mould. In 1974 a new process with fixed pre heat parameters and a larger Thermit portion was introduced. This, the SkV process, produced a more reliable weld and SmW was discontinued. It follows that older cwr from before 1974 has welds that are more prone to failure.

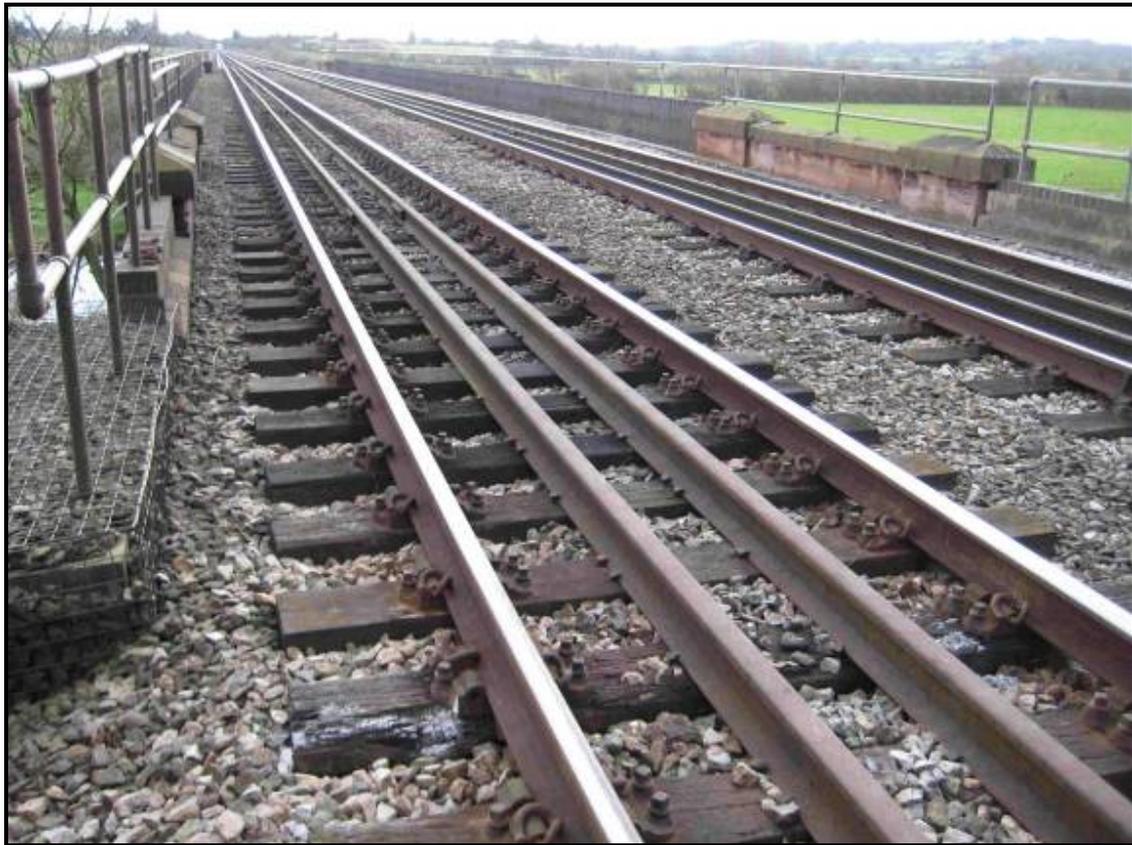
Figure 42. Defford down line renewal site over the river Avon bridge looking south

The section of track between 73m 1733 yards and 74m 352 yards is 1969 rail, F23 sleepers and limestone ballast. At the southern end the line moves into cutting and there is a lineside drain. The drivers for renewal are the dirty limestone ballast and rail which is now prone to defects being 39 years old. The section to the north which includes the hardwood sleepered track over the bridge also moves into cutting at the north end with cess drains. The hardwood sleepers are starting to decay with some showing severe decay. The track is straight over the river bridge and there are no signs of lateral movement at the Pan 11 baseplate seat. As the photograph shows, the geometry is good, although there is some rail memory leading to poor top in places. The current line speed is 100 mph, although there are considerations being given to raise this to 110 mph. Track category is 1 and the EMGTPA figure is 16.4.

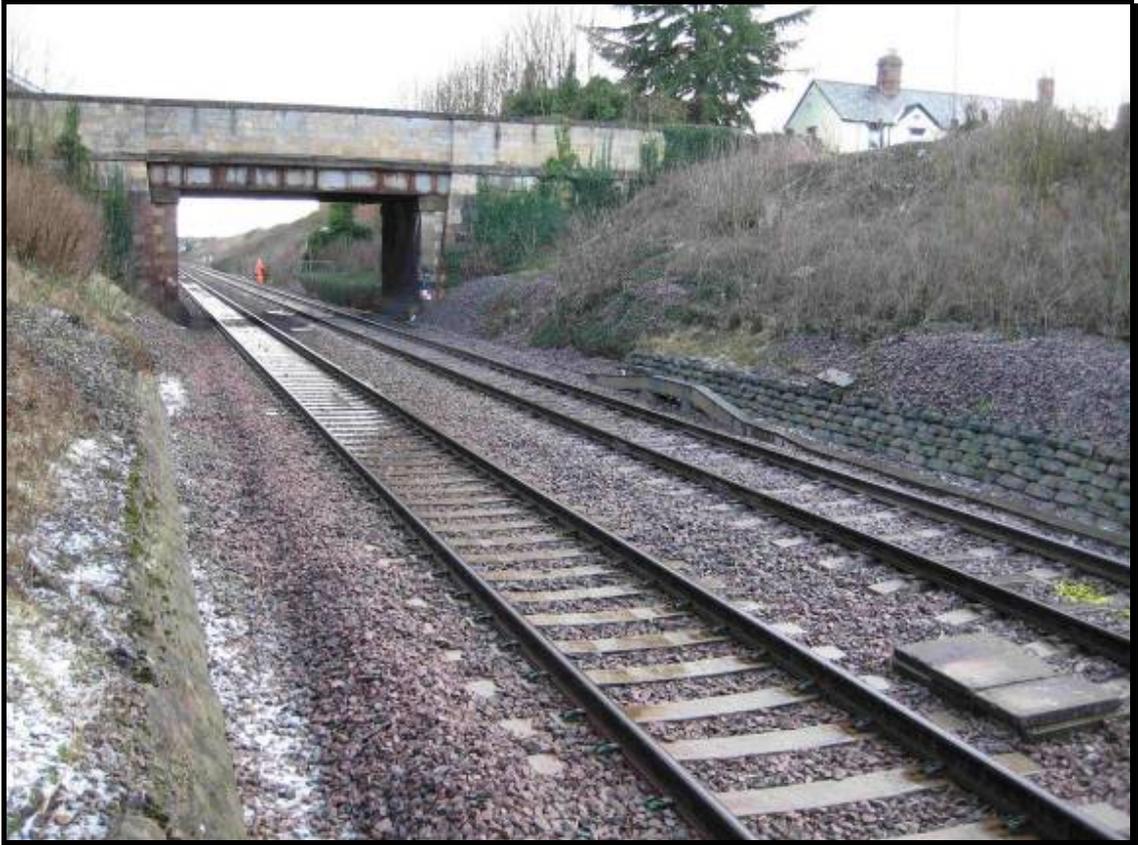
**Figure 43. The track proposed for renewal is the farthest from the camera**

The track is 1966 110A cwr on F19 concrete sleepers and SHC fastenings. For some time the track under the overbridge has been giving problems due to severe ballast attrition. The photograph shows dirty ballast heaped on the bank by the bridge abutment. Matters were exacerbated in 2005 when the down line was renewed and the cross drain from the six foot to the down cess damaged. Correct attention to the drainage and formation at this location is essential if value for the renewal in 2009/10 is to be realised.

None. This item should be undertaken in 2009/10 due to the failure of the drainage system and the track formation through the underbridge. From site observation the local maintenance team will be making regular visits to keep this section of the renewal in good condition to prevent a temporary speed restriction before renewal.

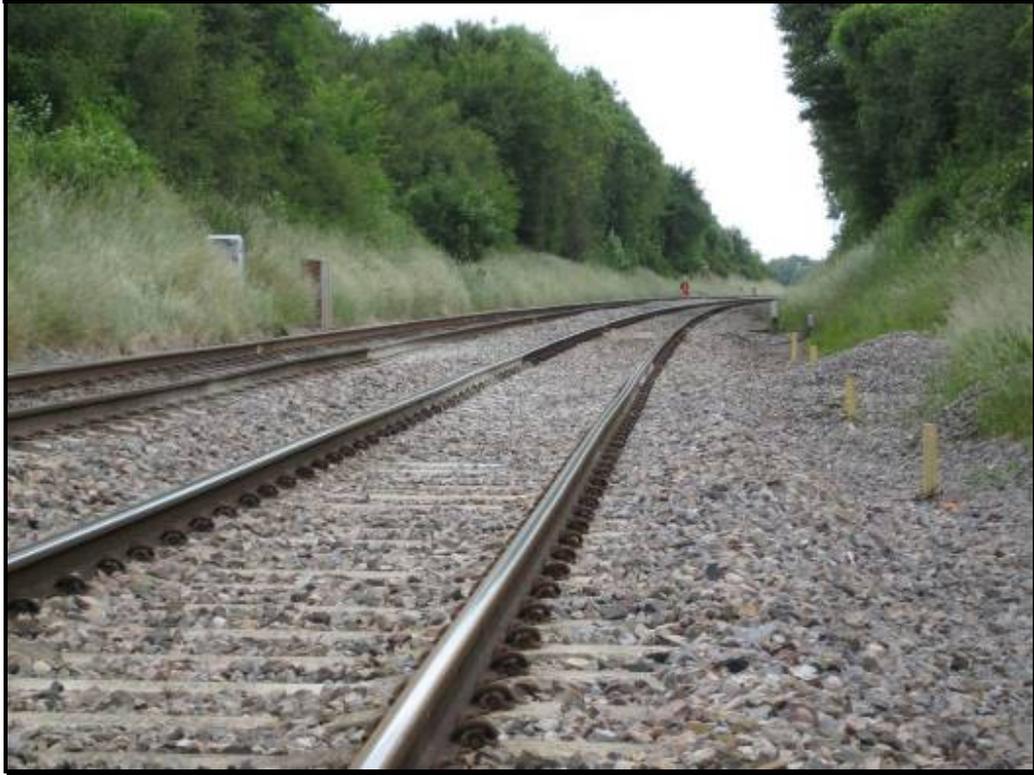
The up track is 1964 110a cwr on F19 sleepers at 26 per 60'-0" with SHC fastenings. Ballast is limestone and granite which is now contaminated with fines and soft silt where the formation has softened and penetrated into the upper ballast layer. The site was ballast cleaned in 1997, however poor and very poor geometry exists over the 440y between the S&C and 107m 1100y due to the poor drainage and soft subsoils. The specification is for new Cen 60 rail, G44 sleepers and 300mm ballast overlying a new formation protection layer with associated new drains to the up cess from 107m 1419y to 107m1210y. The renewal high mileage end abuts existing new G44 plain line track installed when the S&C at Berkley Road Junction was renewed.

Figure 49. The up line looking away from Berkley Road Junction.
